Determination 2010/50

Determination regarding the refusal to issue a code compliance certificate for a 9-year-old building containing eight semi-detached townhouses at 20 to 20G Ruakiwi Road, Hamilton

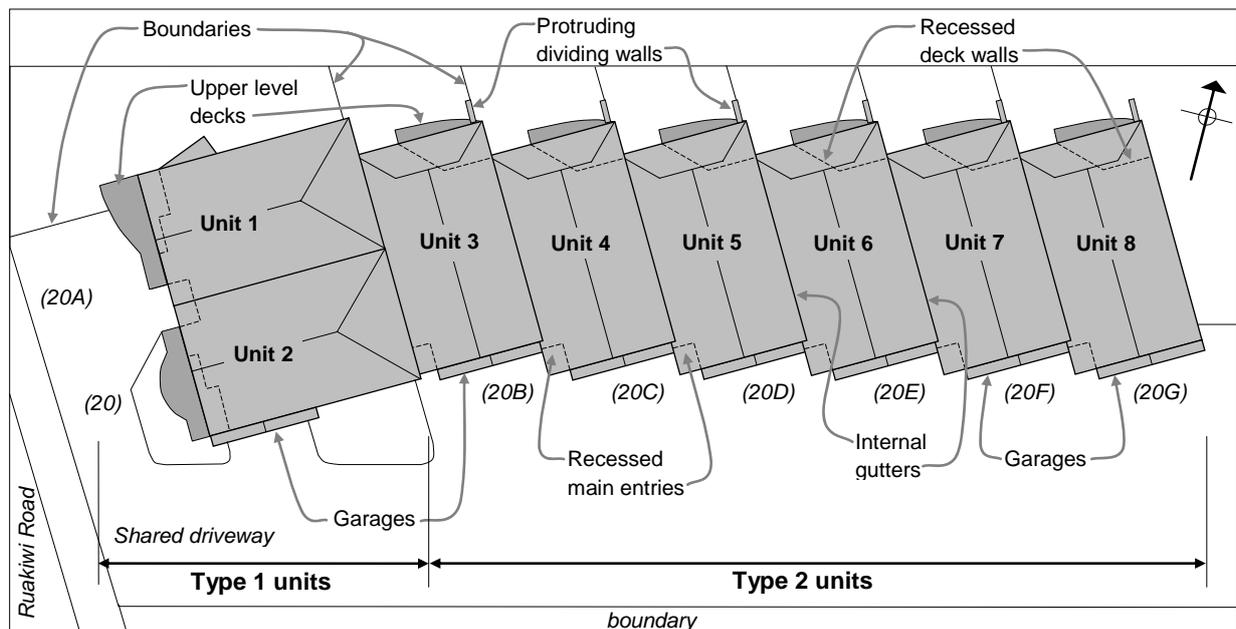
2.1 The building is two-storeys high and situated on a narrow east sloping site in a medium wind zone in terms of NZS 3604⁴. The building sits along the site, with a shared driveway providing access to the units. The units are staggered in plan and step down the slope of the site as shown in the following site plan:
