Determination 2010/062

The refusal to issue a code compliance certificate for a five-year-old house inspected by a building certifier at 112 McAlister Road, Whangarei

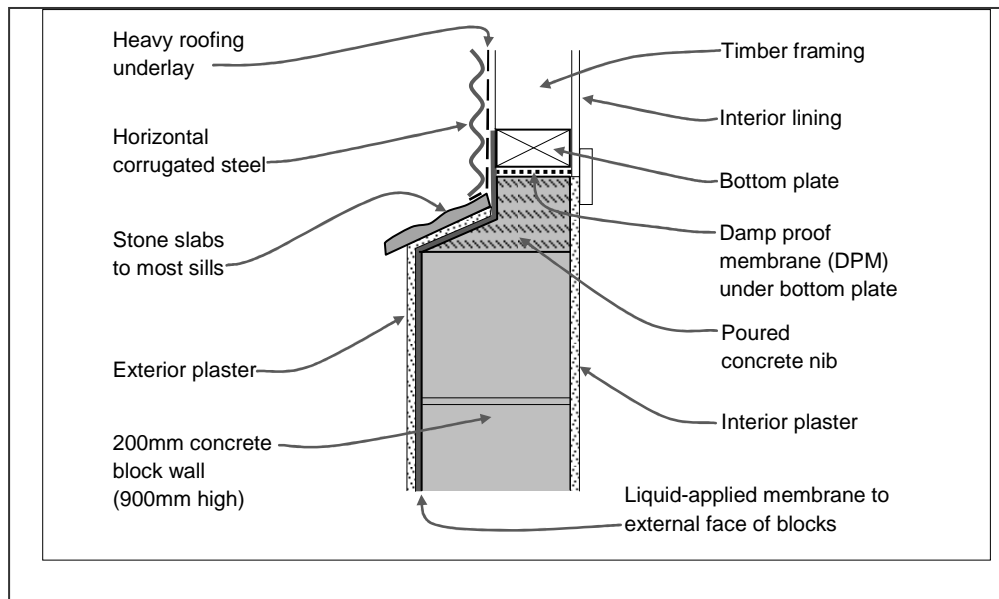
2.3.1 The lower 900mm of the house exterior walls are 200mm thick concrete block, with a plastered finish applied to the interior and exterior surfaces (in the latter case over a liquid-applied membrane). A concrete nib to the top of the block-work supports timber framing clad in horizontal corrugated steel. The general construction is shown in the following sketch:

5.3.2 The expert removed sections of metal cladding in the entry recess, and noted the liquid-applied membrane applied over the concrete nib and up the face of the bottom plate. The expert was unable to confirm whether the membrane extended down the face of the concrete block as shown in the drawings, although he noted that there were no signs of moisture penetration through the plastered block walls.
