## The issue of notices to fix for alterations to five chalets at Waiheke Resort, 4 Bay Road, Waiheke Island, Auckland

### 1. The matters to be determined

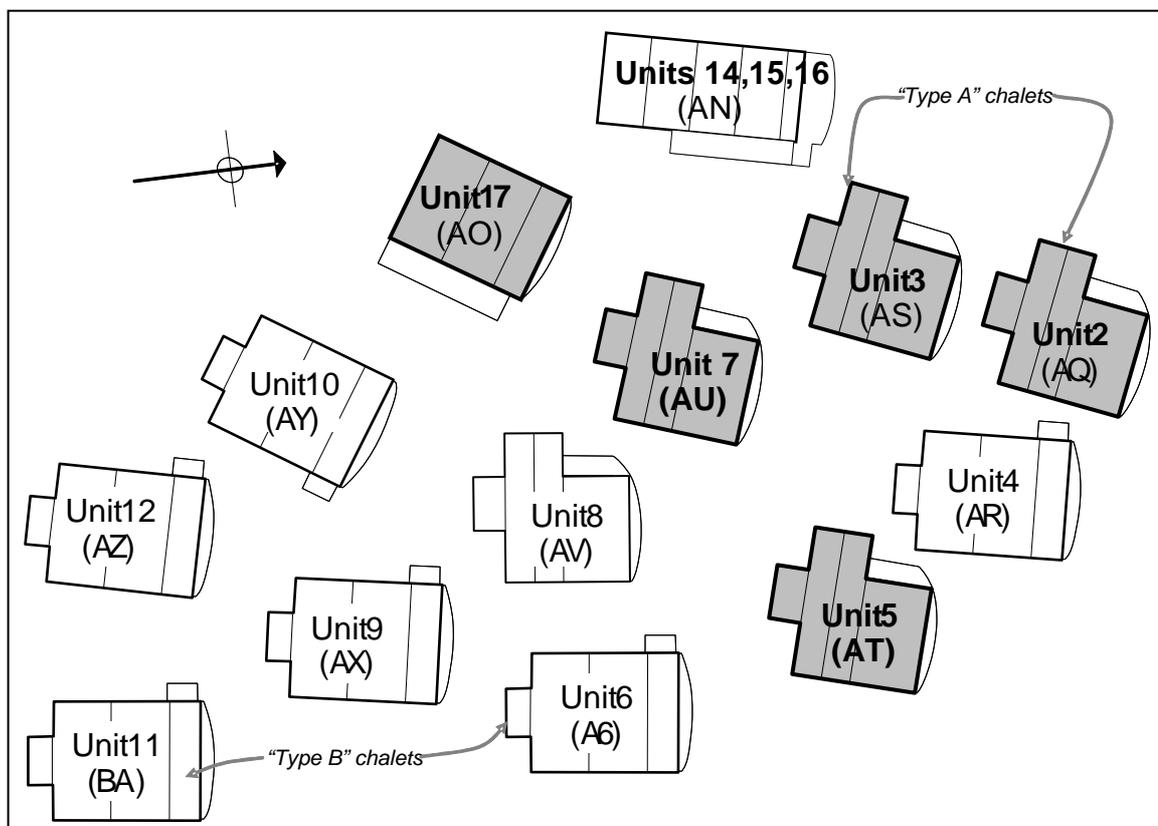
2.3.1 The chalets, with neighbouring buildings, are shown in the following sketch:

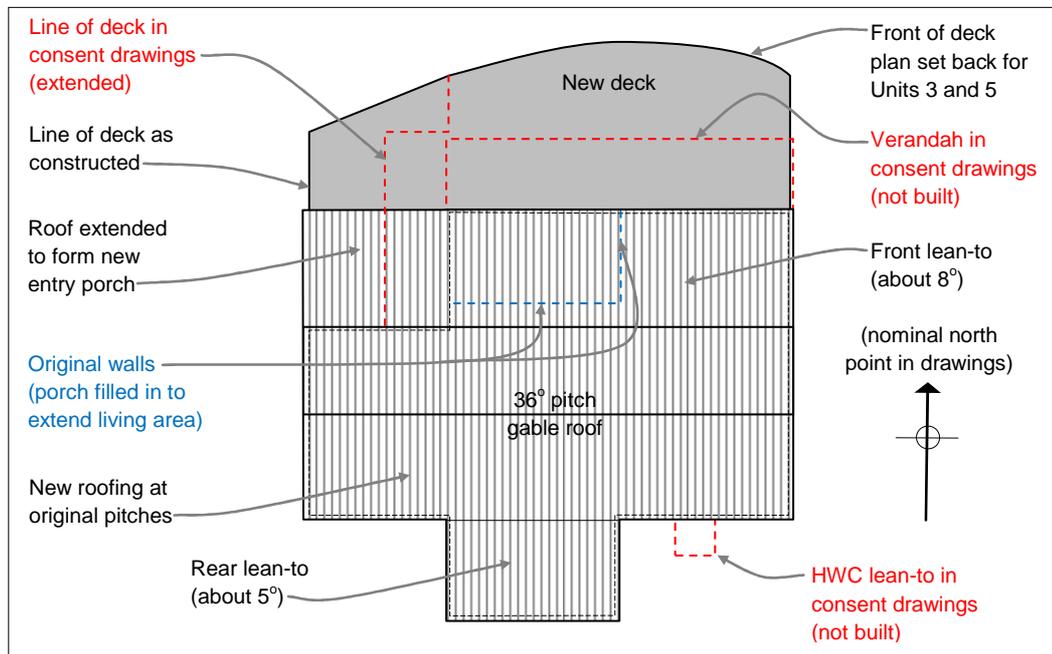
2.4.4 The following sketch compares outlines of the original chalets, the consent drawings and what generally appears to have been constructed:

2.4.5 The 36° pitch gable roof has no eaves or verge projections, and reduces to 5° pitch over the rear lean-to and about 8° over a front porch and bedroom. The consent drawings showed the low pitched roof extending as a verandah above the front deck.

2.4.6 The consent drawings call for the exterior wall cladding to be texture-coated fibre-cement ‘fitted over existing plywood’. The consent drawings also call for existing windows to be removed and replaced with new aluminium windows of different sizes installed in different locations. For most of the chalets, at least some windows appear to be unchanged in size and position.
