## Determination 2010/070

### The issue of notices to fix for alterations to a building at 14/15/16 Waiheke Resort, 4 Bay Road, Waiheke Island, Auckland

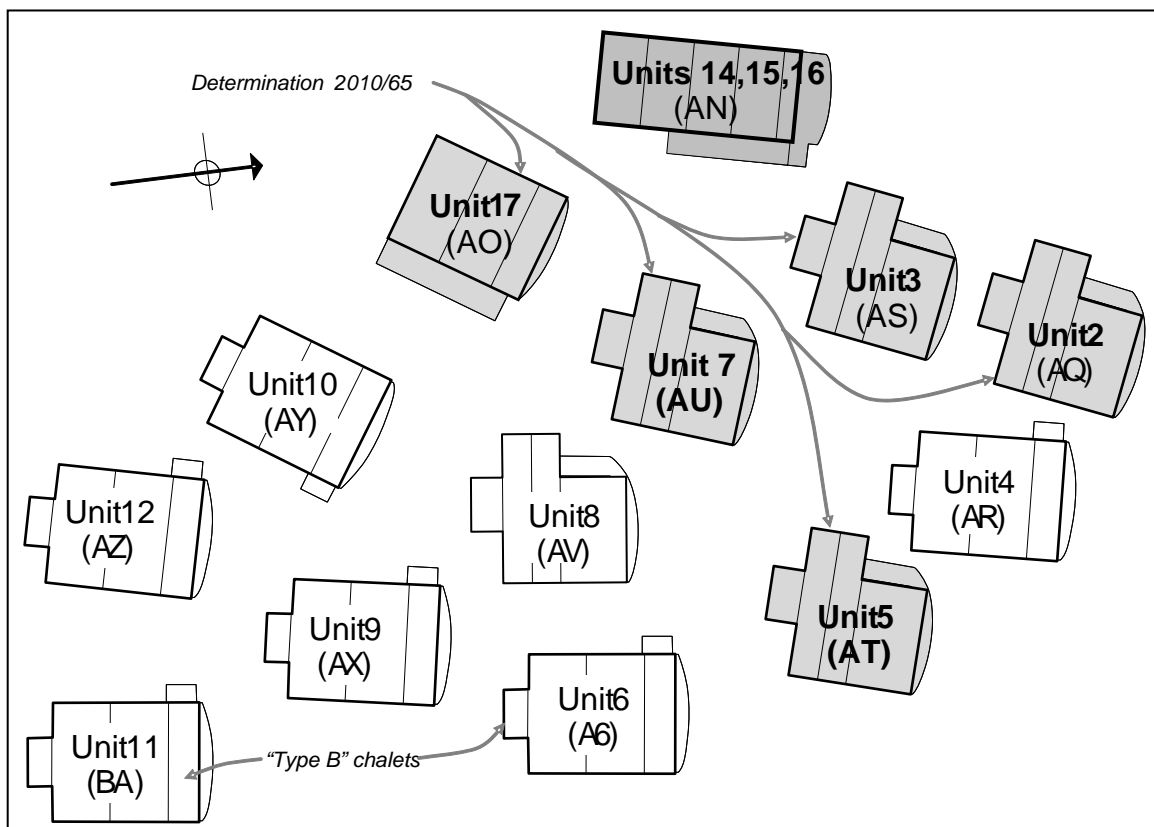
- 2.3.1 Building AN has a single 'unit title' that includes 3 motel-style units. The building, together with neighbouring buildings, is shown in the following sketch:
