Determination 2010/115

Refusal to issue a code compliance certificate for one of a complex of six 15-year-old townhouses at 8 Moturoa Street, Thorndon, Wellington

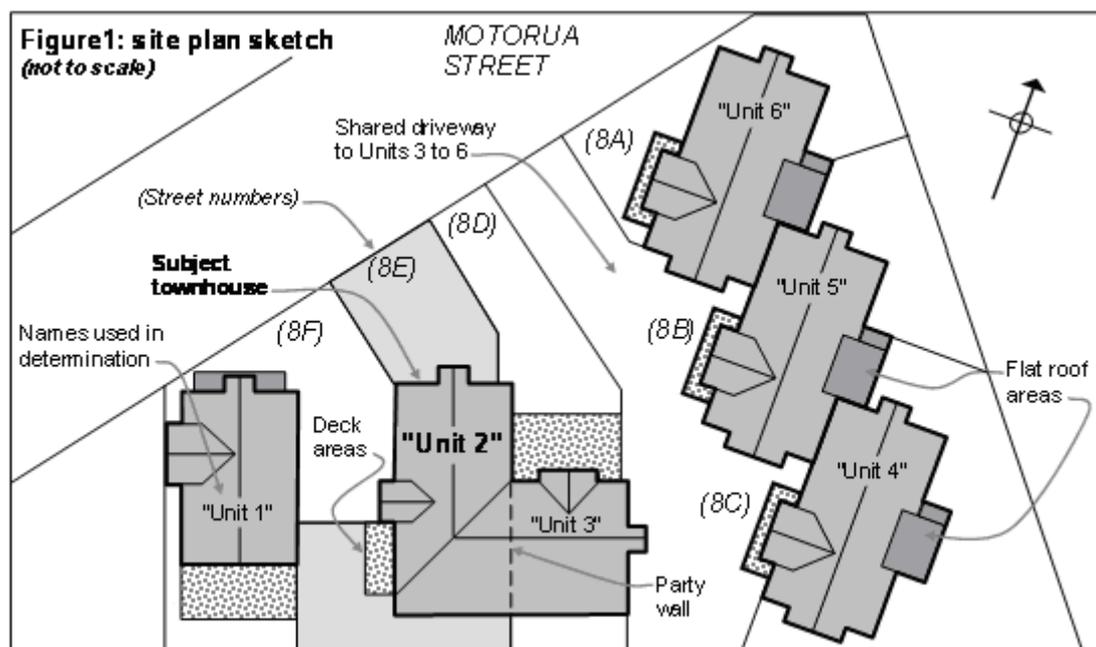
- 2.1 The gently sloping site is in a very high wind zone in terms of NZS 3604⁴ and has been subdivided to provide six properties with separate titles. The units were constructed under one building consent and are similar in materials and design, with some variety in planning. The development consists of a free-standing unit (Unit 1) at the western end of the site, a group of three semi-detached units to the east (Units 4 to 6) and a two-unit building in the between (Units 2 and 3).
- 2.2 The units are three-storeys-high and provide one bedroom on the ground floors, living areas on the first floors and two bedrooms on the second floors. The units are grouped as shown in the site plan sketch in Figure 1:
