Determination 2011/012

Refusal to issue a code compliance certificate for an 11-year-old part of a house with monolithic cladding at 541 Redoubt Road, Flat Bush, Manukau

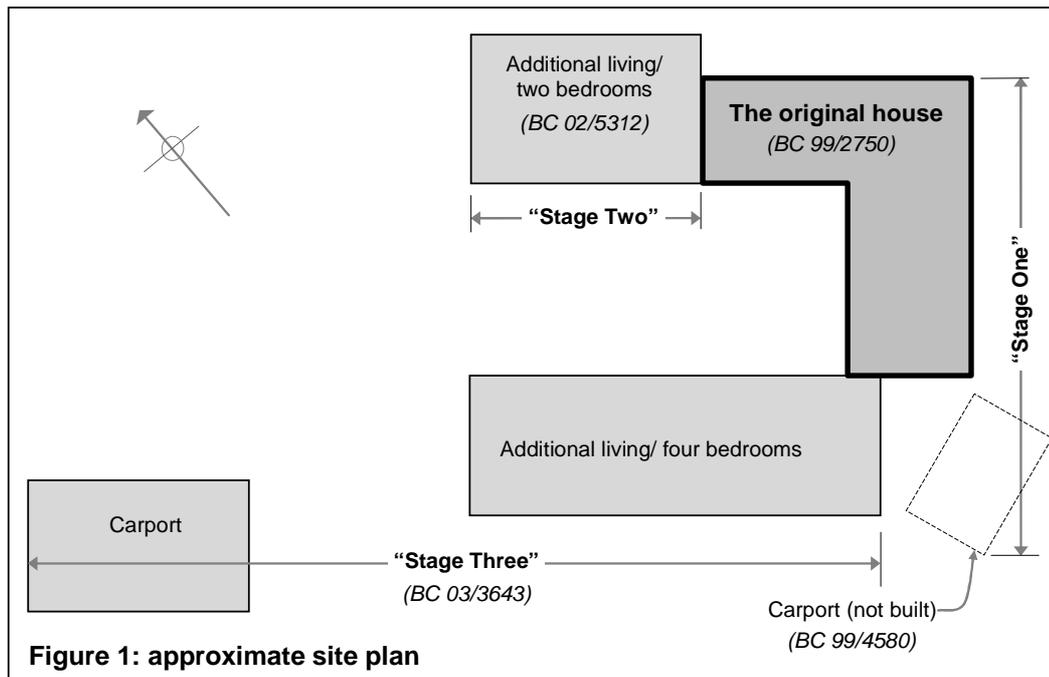
- 2.1 The building work considered in this determination is the original house in the first stage (“Stage One”) of the construction of a large house on a flat rural site in a high wind zone for the purposes of NZS 3604⁵. The work took place over about five years as shown in Table 1. The completed house is a large U-shaped nine-bedroom residence. Stage One is in the eastern corner of the completed house as shown in Figure 1:
