Determination 2011/045

The durability of support brackets installed in the concrete floor slab to an aircraft hangar at 1627 Manapouri-Te Anau Highway, Southland

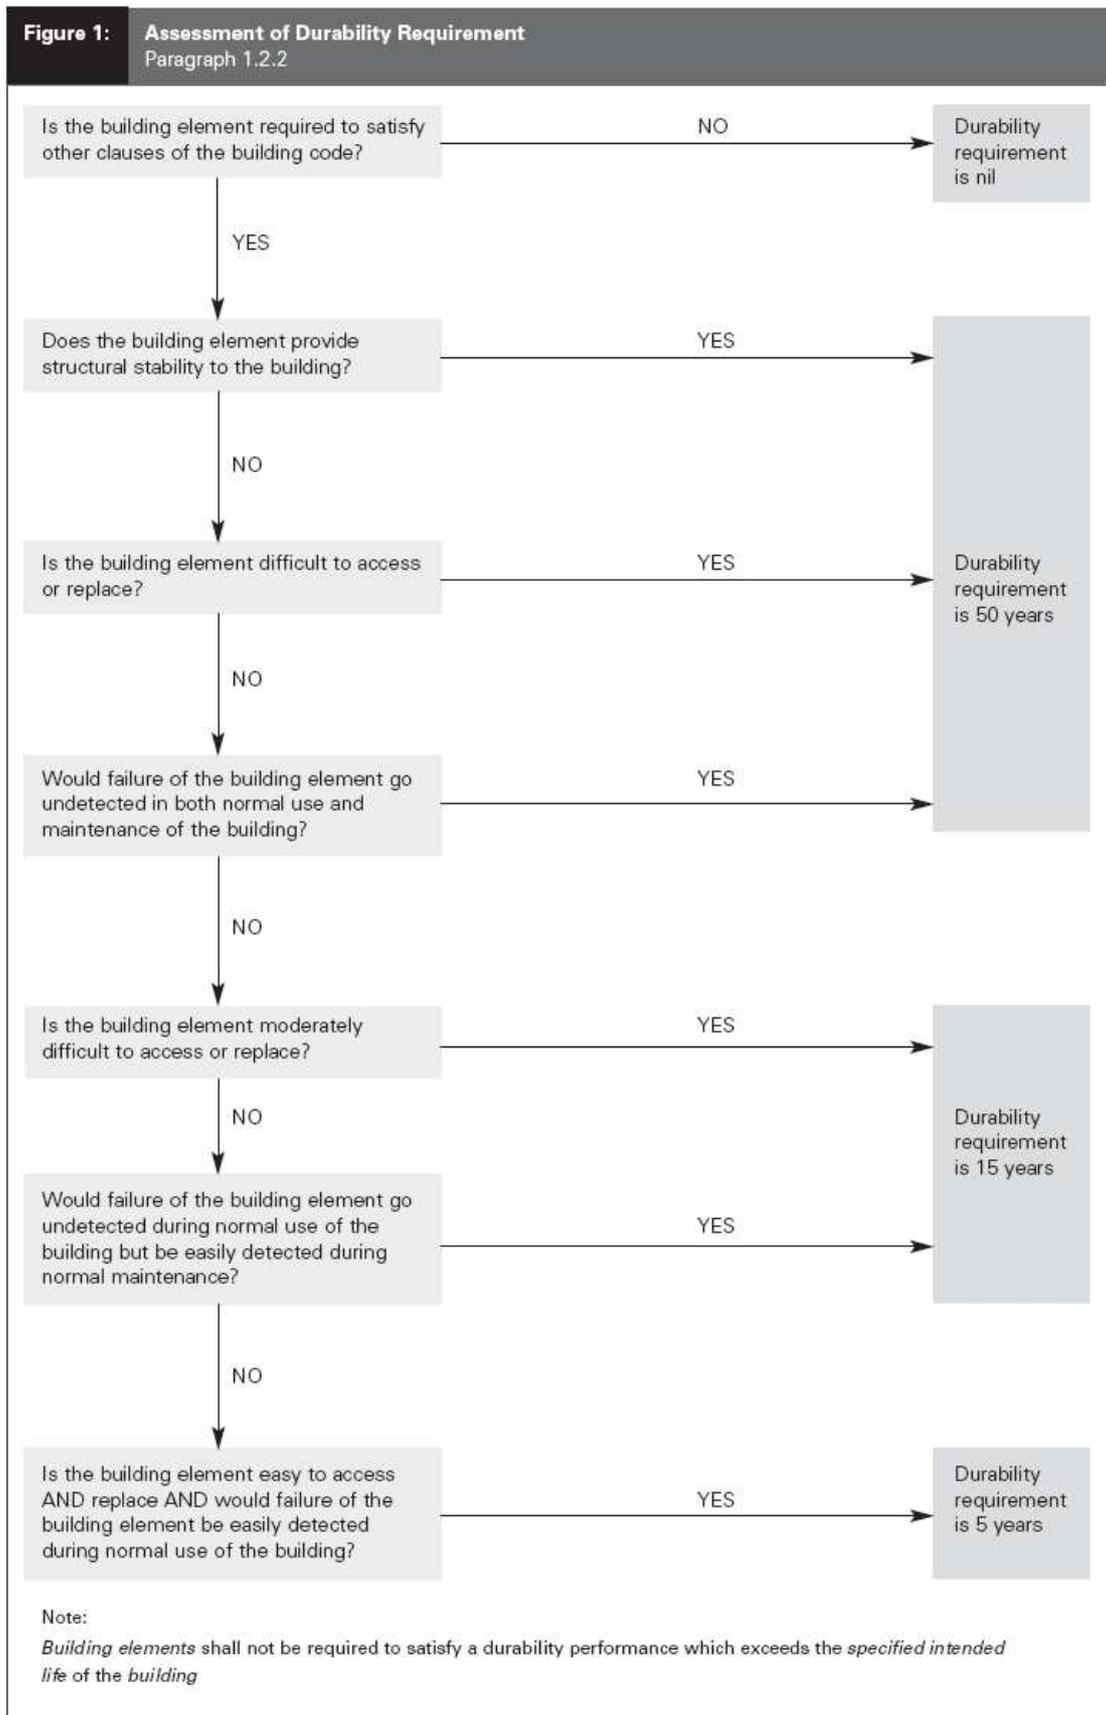
Figure 1 from B2/AS1:

- a) **Difficult to access or replace** – applies to building elements where access or replacement involves significant removal or alteration of other building elements. Examples are works involving the removal of masonry or concrete construction, or structural elements or repair of buried tanking membranes. A 50 year durability is required.
