Determination 2011/049

Regarding the refusal to issue code compliance certificates for alterations to a house at 20 Lambley Road, Titahi Bay, Porirua

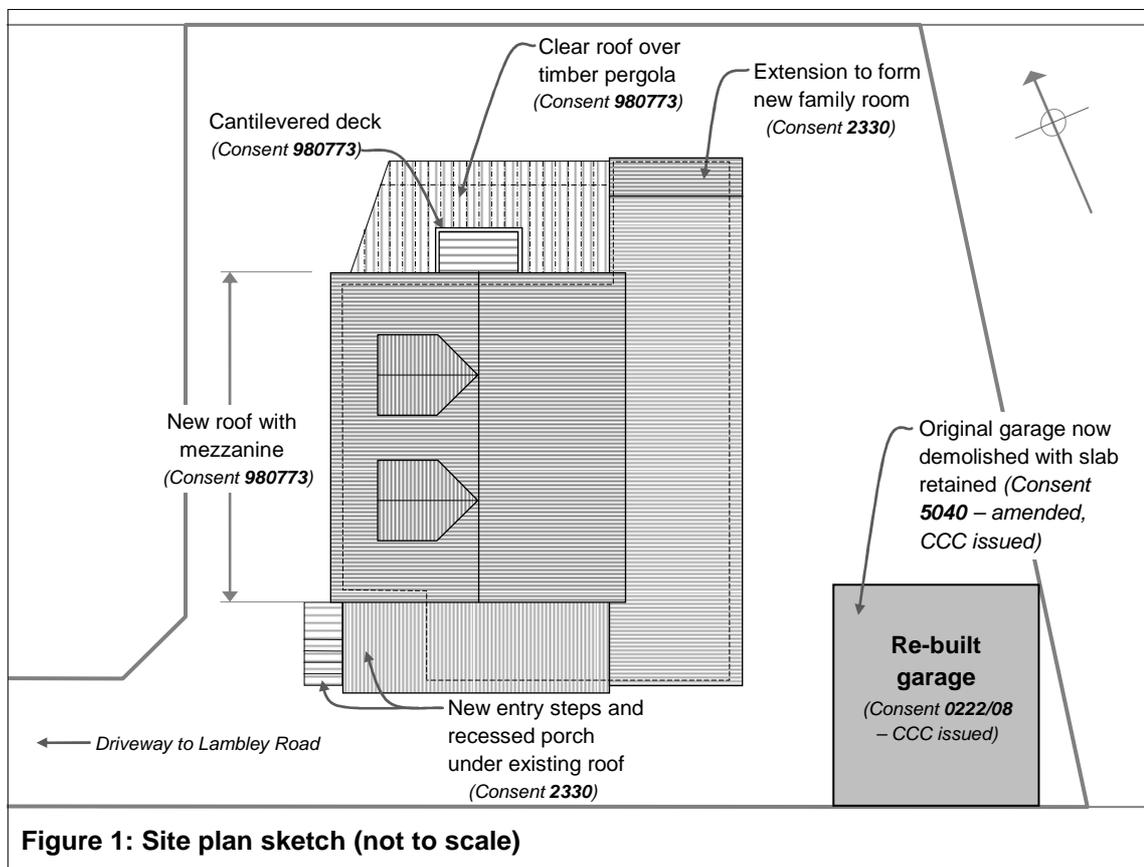
2.1 The building work consists of alterations to a detached house situated on the rear section of a gently sloping sub-divided site. The coastal site is exposed to the south in a very high wind zone for the purposes of NZS 3604⁴. The alterations to the house are indicated in the following sketch:

- the replacement of the original gable roof with a 37° pitch gable roof
- two west-facing dormer windows and windows in gable ends
- a 3.6m deep mezzanine above the north bedrooms, with access via a ladder.

- glazed doors in lieu of north upper gable end window and a small deck added
- a staircase to the mezzanine in lieu of a ladder
- a door removed and opening widened between dining and living rooms
- windows replaced with glazed doors to dining room and north bedroom
- addition of a clear-roofed timber pergola to northwest corner
- addition of a window to east wall of entry porch
- replacement of original timber window sashes with aluminium sashes.
