Determination 2011/055

Refusal to issue a code compliance certificate for 8-year-old alterations and additions to a house at 123A Marine Parade, Mount Maunganui

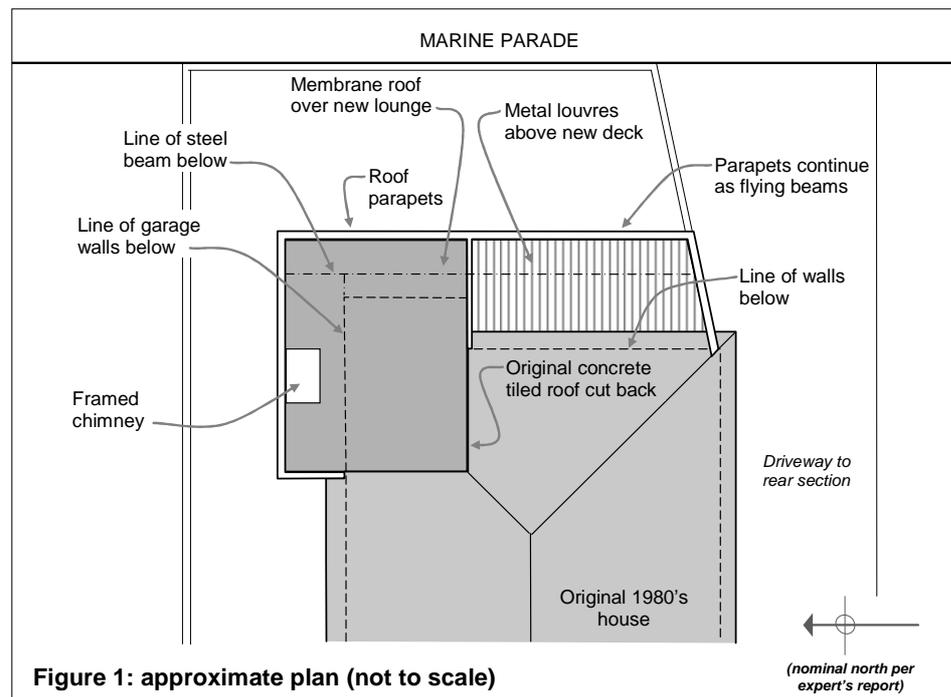
Figure 1: approximate plan (not to scale)

2.3.2 The additions are to the front of the house as shown in Figure 1:

- 2.3.3 Construction is conventional light timber frame with monolithic wall cladding, aluminium windows and a flat membrane roof above the new lounge. The floor to the new lounge is cantilevered to the north and east from a free-standing steel beam and post structure. In line with the lounge east wall, the new deck also cantilevers beyond the steel structure. At the north wall of the lounge, a framed and clad 'chimney' structure extends through the membrane roof.
