Determination 2011/059

The refusal of a code compliance certificate for a 10-year-old residential care facility completed under supervision of a building certifier at 11 Messines Road, Karori, Wellington

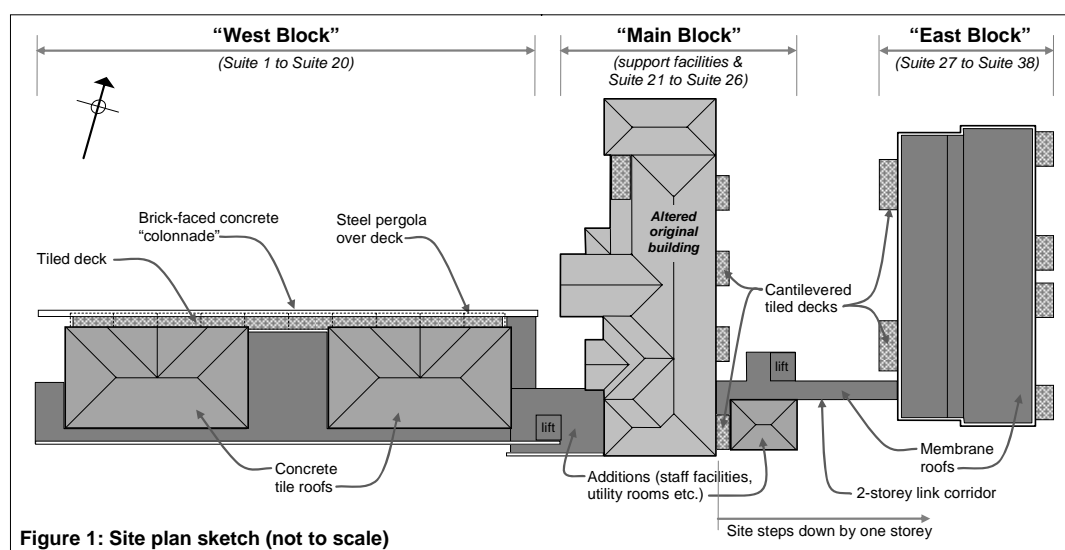
2.2.1 The upper level of the site accommodates a new building ("the West Block"), the original building ("the Main Block") and a car park. East of the original building, the site steps down and the third building ("the East Block") is set one storey lower than the ground floors of the other buildings as shown in Figure 1:
