## Determination 2012/014

### The code compliance of a deck incorporating a floating in-situ concrete slab over a waterproofing membrane at 38 View Road, Waiheke Island

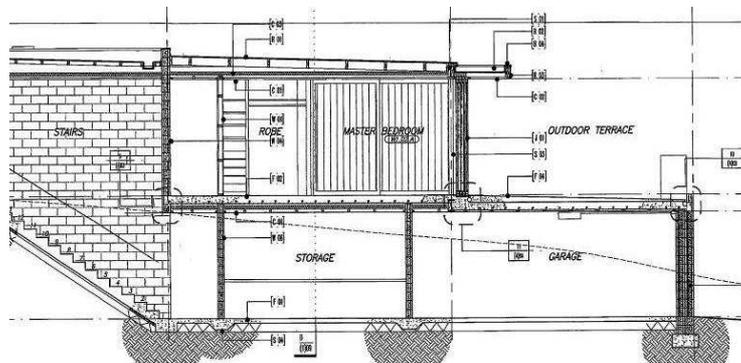
Figure 1: Section through deck as originally consented

- permanent formwork consisting of either 4mm stainless steel sheet, or 15mm H3.2 CCA plywood to maintain the minimum slab thickness, over
  - pedestal support chairs at 300mm centres each way, over

- a two layer torch-on membrane (consisting of 2x3mm layers), with additional 150mm wide membrane strips located under each pedestal, over the existing floor slab.
- 2.5 The deck slopes away from the first floor walls to a perimeter edge drain. A stainless steel channel drain and grate is to be installed where the deck abuts the first floor walls. The membrane has a current BRANZ<sup>4</sup> appraisal certificate. The membrane manufacturer has offered a 20-year product warranty for the use of the membrane in this location.
