Determination 2013/062

Regarding the issuing of a code compliance certificate for building work affecting other property at 2C Hastie Avenue, Mangere, Auckland

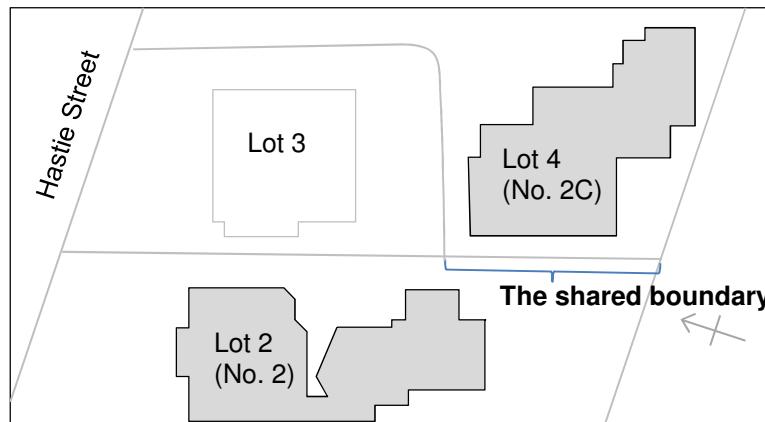
Figure 1: site plan (not to scale)

- 2.1 The building work in question concerns the excavation at the boundary shared by Lots 2 and 4 to provide a flat building platform at Lot 4, and the affect of that excavation on Lot 2.
- 2.2 The original parcel of land was sub-divided into four sections and the overall site slopes from the street front down toward the south. The house on Lot 2 is located towards the north and west of Lot 4, with a large yard to the south. Lot 4 adjoins the east boundary of Lot 2 for approximately a third of the total length of Lot 2 (“the shared boundary”). The shared boundary is 20.8m long.

- 2.3 The height difference between the two properties either side of the shared boundary is approximately 2.3m at the northern end; this reduces slightly towards the south where it then drops away suddenly to be almost equal at the south boundary.
