## **Determination 2014/044**

# **Dispute about the compliance of overlay flooring in an 8-year-old apartment at 134 Waterfront Road, Mangonui**

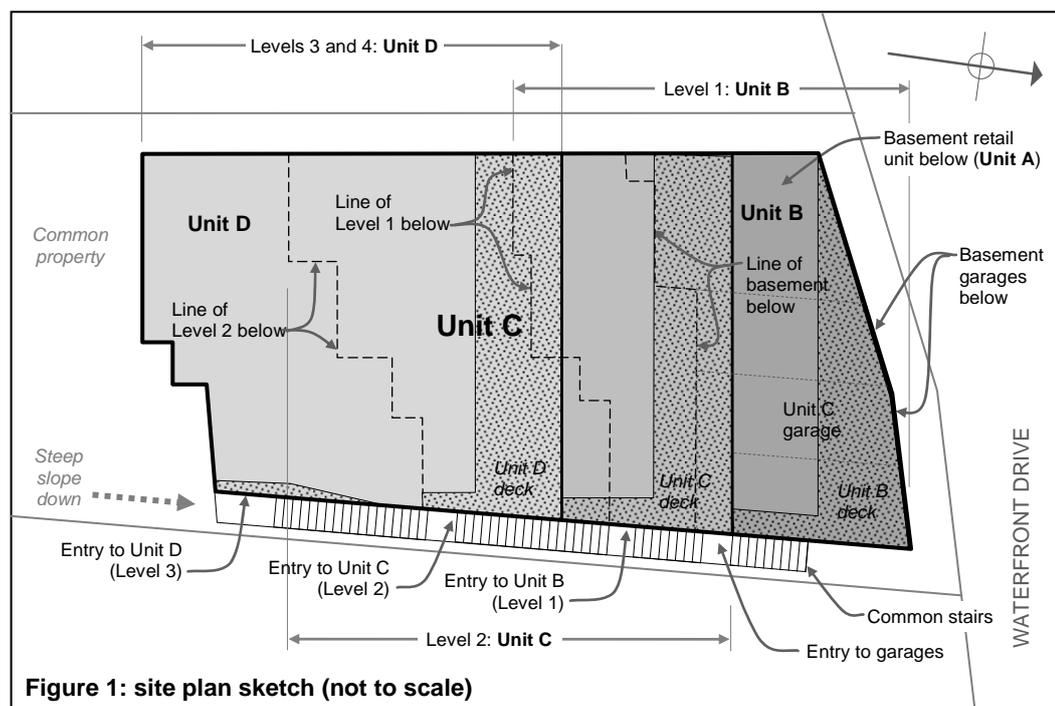
2.2 The building accommodates three dwelling units, one retail unit and three garages as shown in Figure 1 below.

- 2.3 As shown in Figure 1, the building comprises four units located over five different levels (see Table 1 below):
