Determination 2015/055

Regarding the code compliance of building work in a new house at 124 Navigation Drive, Whitby, Porirua

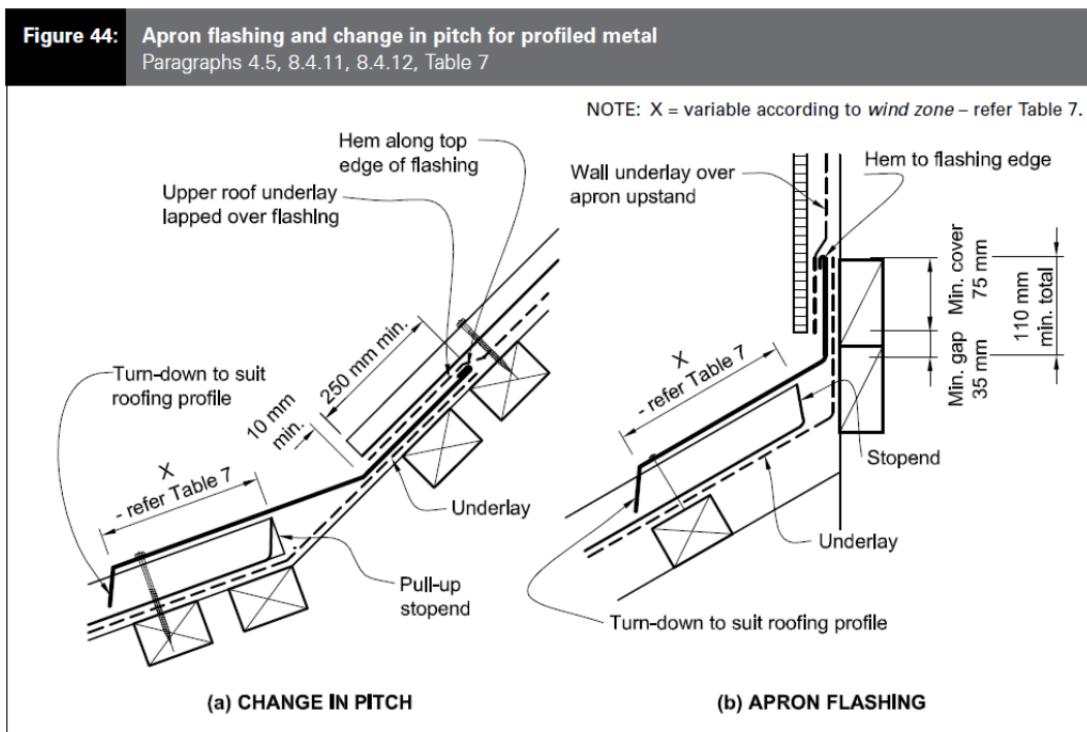
A.2 The relevant Figure from Acceptable Solution E2/AS1 includes:

- In the absence of underlay and turn-up troughs in the metal to metal detail, the flashing as-built relies on a form of sealant (bituminous corrugated foam infill strips/profile closures) to prevent wind-driven rain from entering at the pitch change. The closures are not designed for this purpose and retained moisture will cause corrosion.

- The metal roof was cut back with the junction partially above the soffit. Consequently part of the enclosed eave, vertically above the soffit boards, is exposed to the junction and there is no underlay. The wind driven rain is able to enter the junction and leak onto the top of the soffit boards.
