Determination 2015/057

Regarding the refusal to issue a building consent for Stage One of remediation to an apartment complex at 716 Frankton Road, Queenstown

This determination discusses the code compliance of proposed wall and roof repairs in respect of interstitial condensation. The analysis took into account the expected occupancy of the units and factors affecting ventilation, the site and location, the past history of damage to the buildings, and the provisions proposed for reducing the risk of condensation.

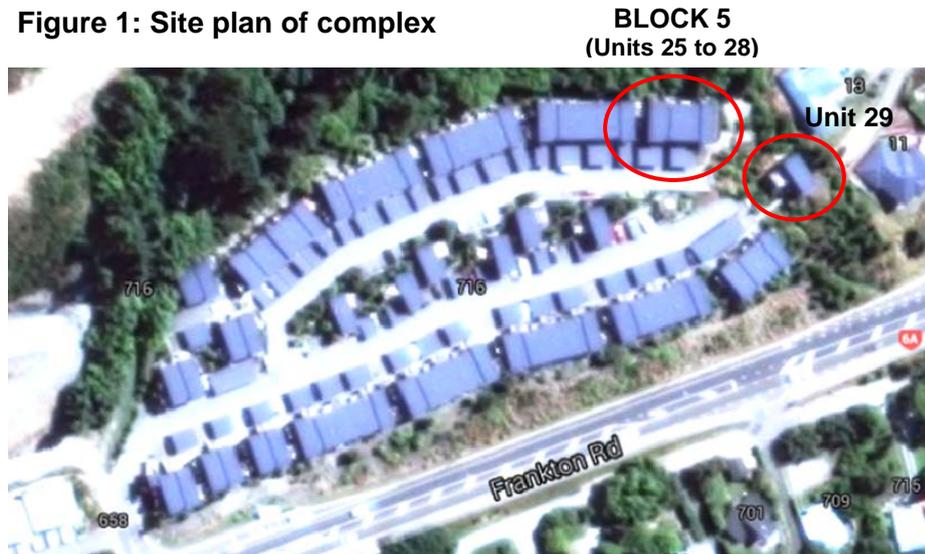
Figure 1: Site plan of complex

2.2.1 Figure 1 shows the general site plan of the complex with the subject buildings outlined in red:

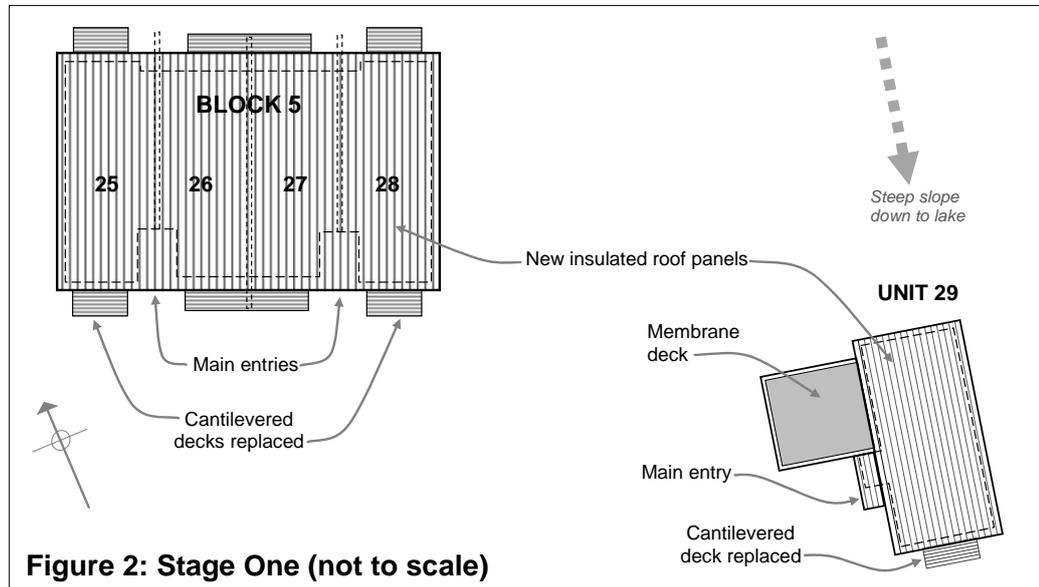
2.3.2 The two subject buildings are shown in Figure 2:

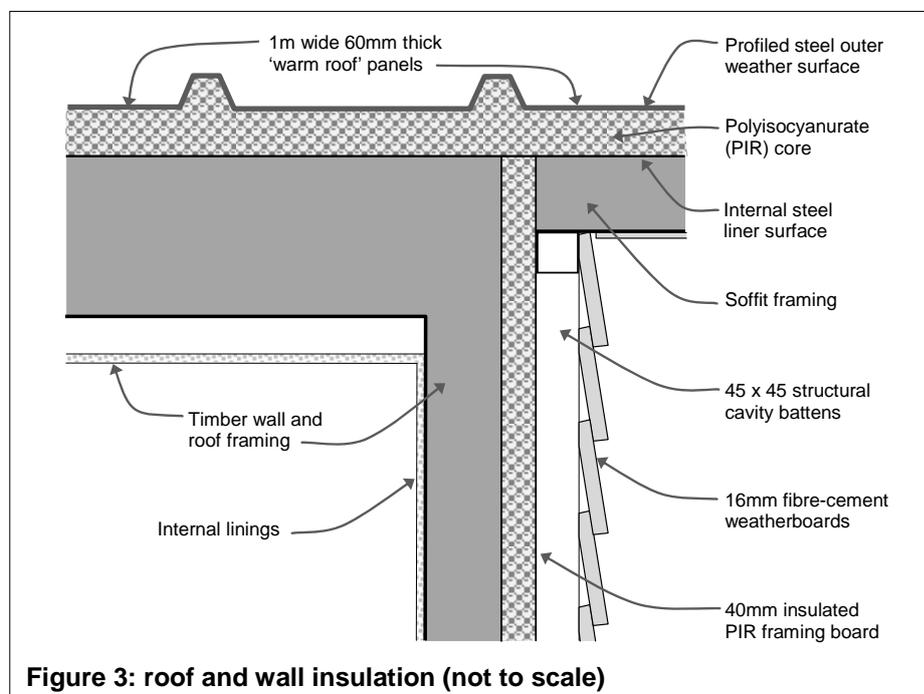
2.4.1 The remedial work includes the installation of insulated roof panels to create a 'warm roof', with insulation board to walls as shown in Figure 3:

- 2.4.2 The sloping skillion monopitched roofs are clad in proprietary insulated roof panels. The 60mm thick proprietary roof panels have a polyisocyanurate (“PIR”) core with colour-coated steel to both faces. Walls will be insulated with 40mm thick foil-faced PIR insulation board fixed directly to the outside of the wall framing.
- 2.5 Heating and cooling is provided via heat pumps and the specification allows for ventilation of moisture sources in the form of:
- kitchen range hoods ducted to the outside
 - shower domes installed over existing cubicles
 - in-line fans to all bathrooms connected to light switches
 - exhaust grilles to dryers.
