## Determination 2015/061

# Regarding the issue of dangerous building notices in respect of cantilevered timber-framed decks to three monolithic-clad apartment buildings at 346 Oceanbeach Road, Mount Maunganui

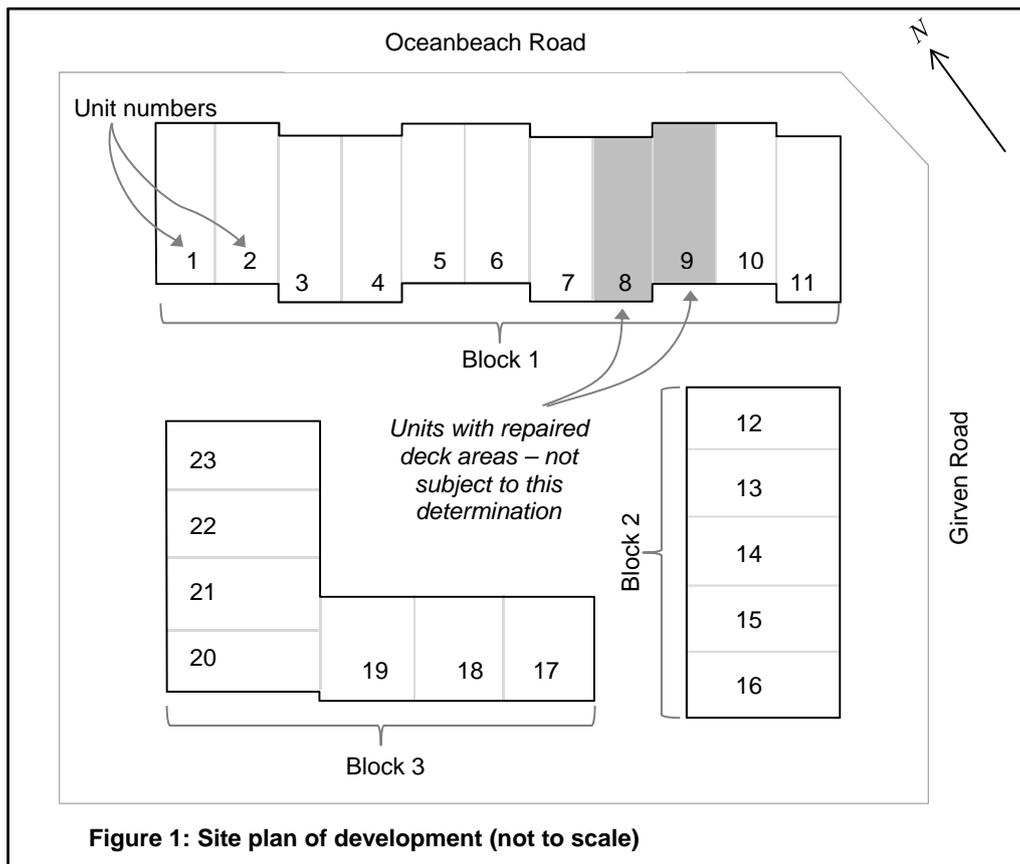
## 2.5 The decks

- 2.5.1 There are decks on the second and third storey of each unit. Approximately half of the decks are partly cantilevered decks supported jointly by the common wing walls and cantilevered floor beams, with 190x45 deck joists spanning between.
- 2.5.2 There is a double 190x45 perimeter deck joist, which powder coated aluminium handrail stanchion base plates are screw fixed to. The return hand rails are end fixed into the side of the common wing wall and to the wall face of the unit; the fixings are 2 stainless steel screws to each of the fixing plates.
- 2.5.3 The wing walls are double frames of 100mm x 50mm timber with a 10mm gap between. The walls are designed to provide fire separation between the units and extend beyond the roof.
