Determination 2015/071

Regarding the refusal to issue a code compliance certificate for an 11-year-old extension and alterations to an existing house at 3 Wahanui Road, Greenlane, Auckland

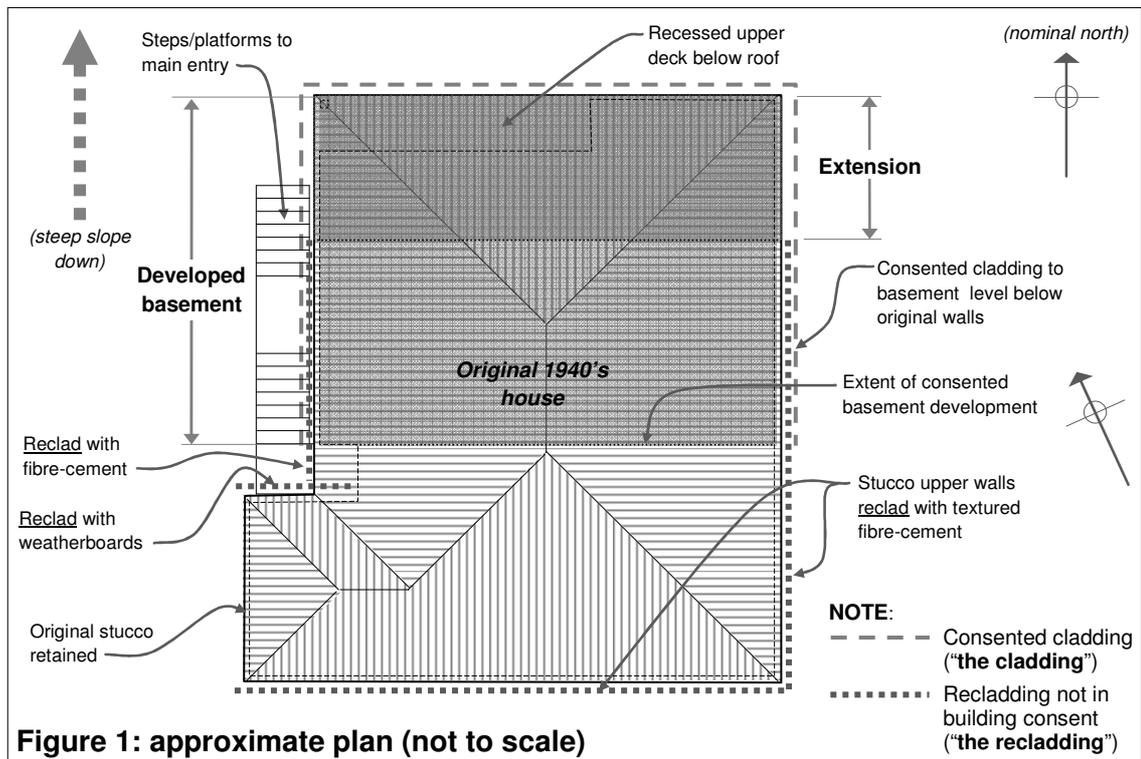
- 2.3.1 The alterations are shown in Figure 1 and include joinery replacement and recladding to the existing exterior walls, which are not considered in this determination (see paragraph 1.5.2).

- 2.3.2 The two-storey extension is to the north of the original house and includes:

- removal of the study and an extension with a deck to the upper living area
- internal stairs to the new partial basement level
- in the basement level:
 - two additional bedrooms
 - family room
 - laundry and an additional bathroom.
