## Determination 2016/049

# Regarding the refusal to issue code compliance certificates for an 18 to 20-year-old house with monolithic cladding at 53 Courage Road, Amberley

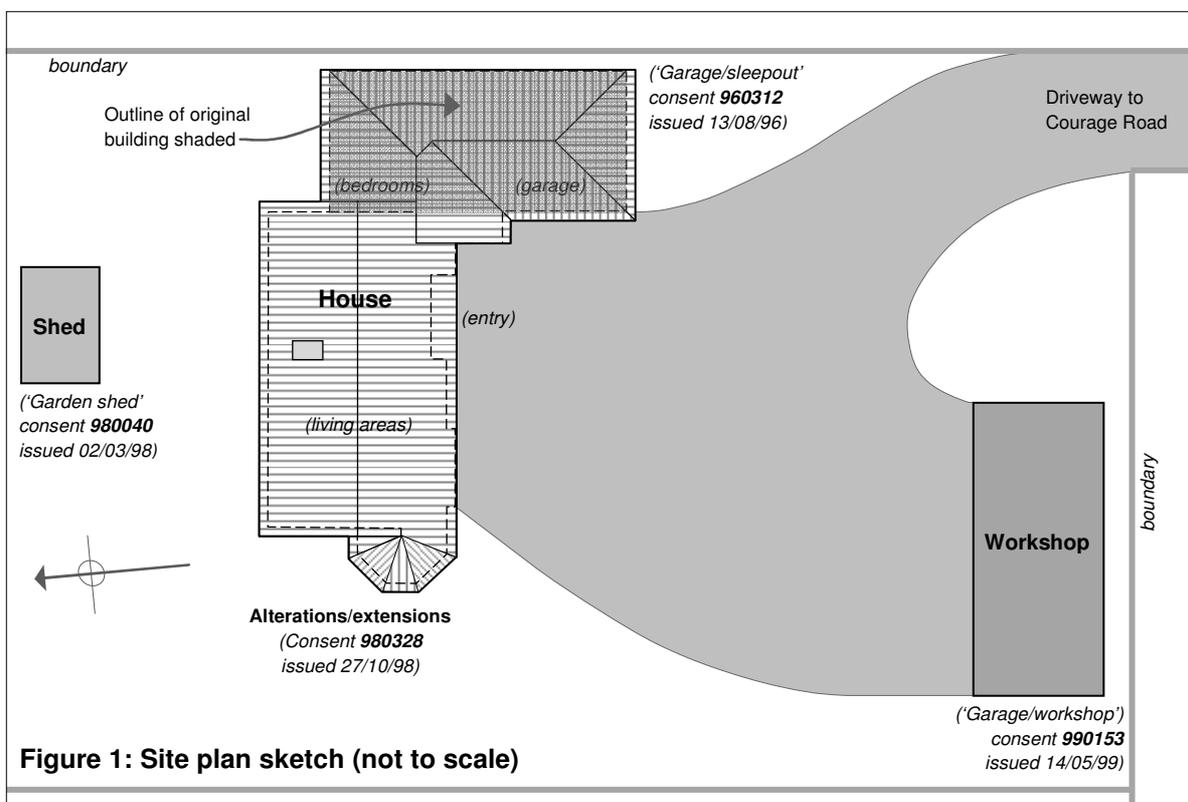
- removal of a veranda that had been added to the west of the original building in 1997
- addition of a new wing to the west, providing living, dining and kitchen areas
- alterations of the original building to provide 4 bedrooms and 2 bathrooms
- new roof framing, roofing and cladding to most walls of the original building.

2.3.2 The resulting house is shown in the site plan sketch in Figure 1:

1.9.1 This determination is limited to the above building consents and does not consider the following building consents issued for other buildings constructed on the same site (see Figure 1):
