## Determination 2017/013

# Regarding the refusal to issue a code compliance certificate for 11-year-old additions and alterations to a house at 56 Hollywood Avenue, Titirangi

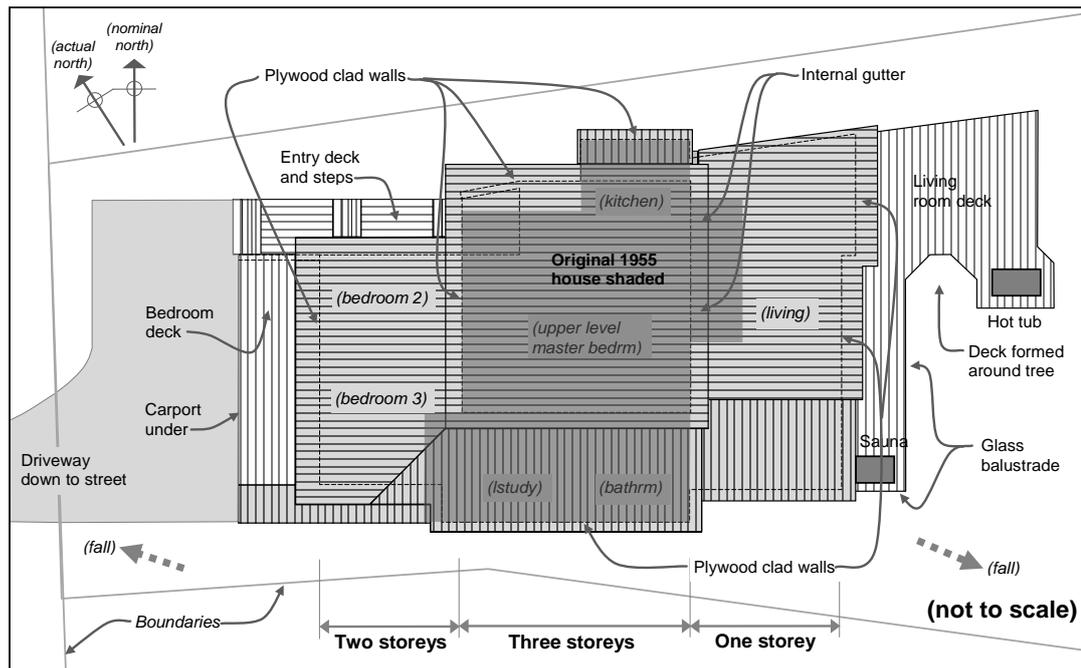
**Figure 1: Approximate site plan**

alterations are shown in Figure 1 and include additions and alterations to all elevations that have left few remaining visual indications of the original cottage.

- Level 1: Carport, with original basement storage area to the east.
- Level 2: Two bedrooms and deck to the west, entry deck/steps and 2-storey high entry hall to the north, study and bathroom to the south, and the kitchen, living/dining and deck to the west.
- Level 3: Master bedroom and ensuite.

2.5.1 The plywood clad walls are noted in Figure 1 and the cladding system appears to be a proprietary cladding product. The cladding comprises 12mm thick bandsawn-faced plywood sheets finished with an acrylic paint coating, which are fixed through 20mm timber battens and the building wrap to the framing. The timber battens form a cavity between the plywood sheets and the building wrap. Vertical joints are rebated, horizontal joints include a metal Z-flashing and timber battens are installed over external corners. According to various bracing calculations, the plywood cladding is
