Determination 2017/034

The refusal to issue a code compliance certificate for a townhouse in a 24-year-old building with monolithic cladding at 6/22 Killarney Street, Takapuna, Auckland

This determination concerns the compliance of a 24-year-old townhouse. The determination considers the authority's reasons for refusing to issue the code compliance certificate and whether the townhouse complies with the requirements of the Building Code.

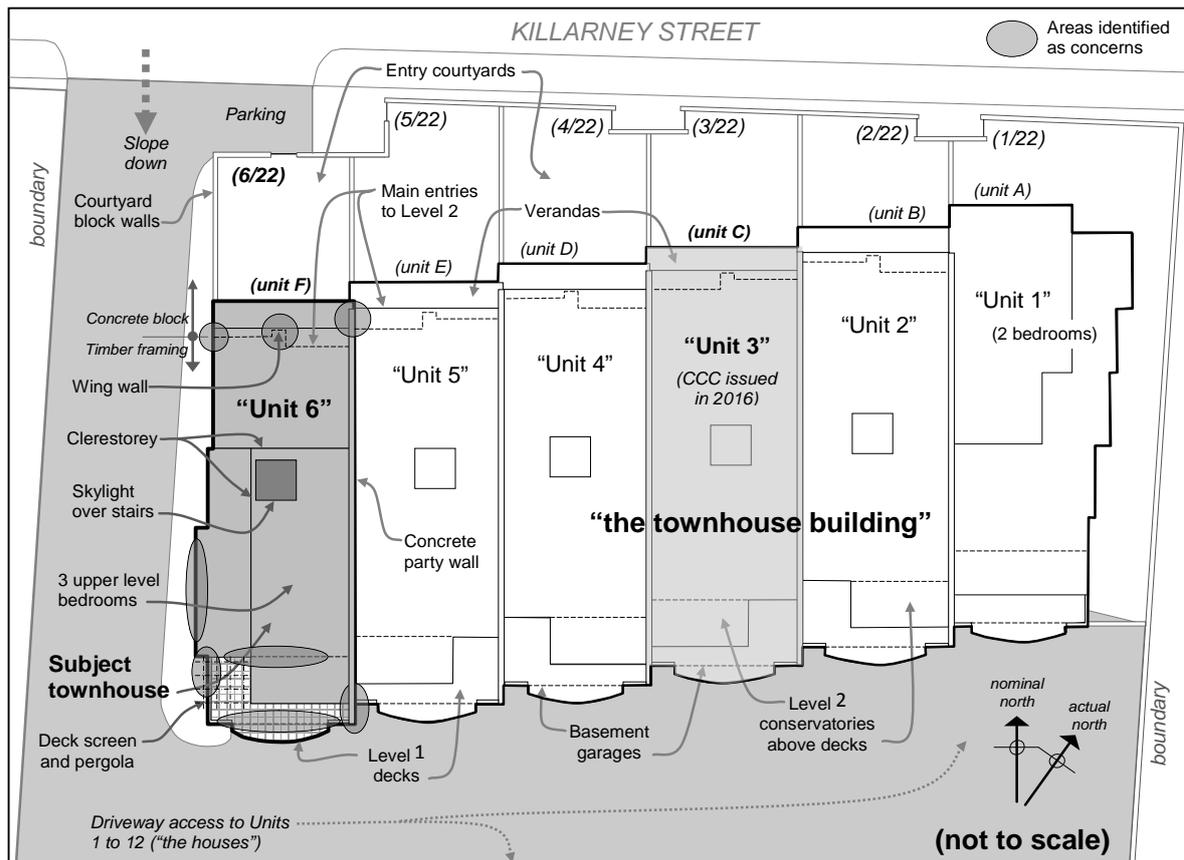
Figure 1: Approximate site plan

2.2.2 Unit 1, at the eastern end has two bedrooms with a partial upper level, while Units 2 to 6 have three bedrooms with a full upper level as shown in Figure 1.

- 2.4.1 Unit 6 is at the west end of the townhouse building as shown in Figure 1, with construction as described above except for the west elevation – where external walls are timber-framed above the basement blockwork. The concrete block party wall to the east extends to the south to form a barrier between adjacent decks. The Level 2 conservatory extends over the deck from the party wall, supported by a reinforced concrete beam at the south west corner.
