## Determination 2017/039

# Regarding the refusal to issue a code compliance certificate for a 15-year-old house with monolithic cladding at 2D MacMaster Street, Richmond, Invercargill

The determination arises from the authority's refusal to issue a code compliance certificate for a 15-year-old house with a monolithic cladding. The determination considers the authority's reasons for refusing the code compliance certificate, and whether the house complies with the requirements of the Building Code with respect to weathertightness and durability.

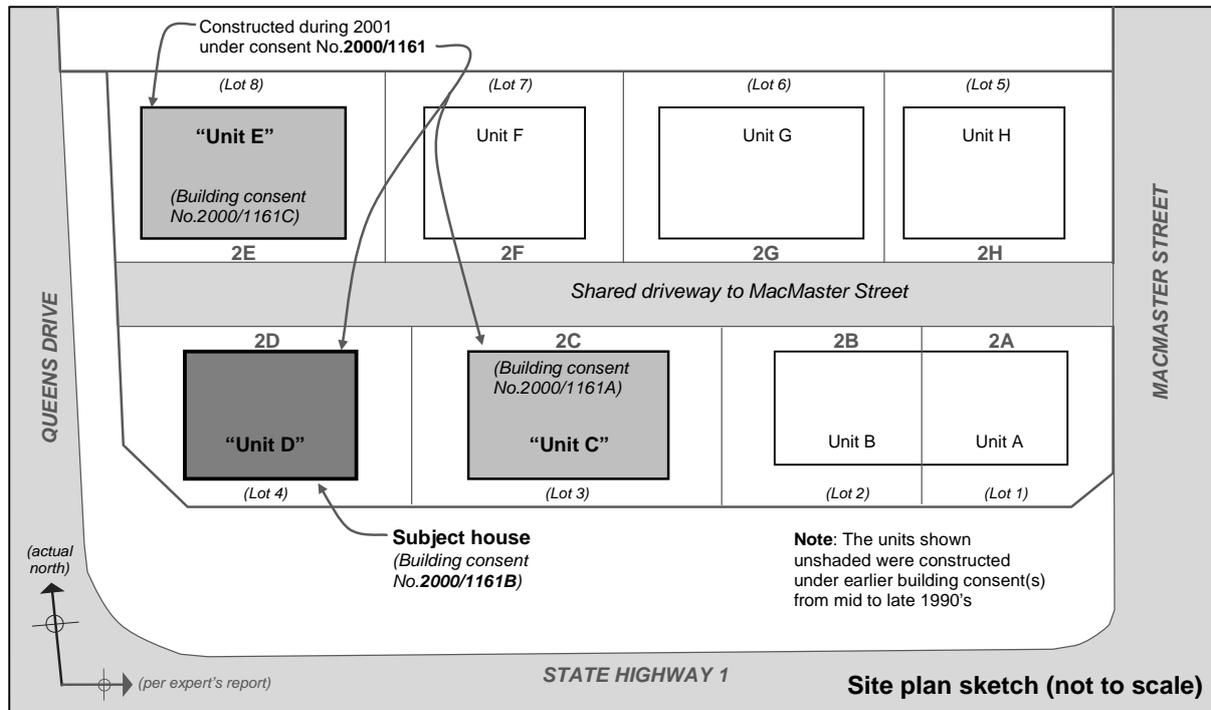
**Figure 1: The development**

2.1.1 The original corner property was subdivided during the 1990's, with separate titles issued on 13 November 1995<sup>4</sup> for eight lots with a shared driveway from MacMaster Street to the east. The detached Units E to H and the semi-detached Units A and B were constructed from the mid to late 1990's, with Units C to E following in 2001. A shared driveway runs from west to east to provide access from MacMaster Street to the garage of each unit as shown in Figure 1.

2.1.2 In his report, the expert took the garage door of Unit D as west-facing, but the drawings and actual orientation of the development show the driveway to the north of Units A to D as shown in Figure 1, and the authority's inspection records for Units

1.5.2 The original building consent (No. 2000/1161) was issued in 2000 for a group of three detached units as shown in Figure 1. In April 2016, the authority divided the original building consent into three separate consents as follows:

5.1.2 As noted in paragraph 2.1.2, I have taken the garage door of Unit D as north-facing and have therefore amended the expert's references in the following paragraphs to align with the actual orientation as shown in Figure 1.
