Determination 2017/046

The refusal to issue a code compliance certificate for a 15-year-old house with EIFS cladding completed under the supervision of a building certifier at 130C Ireland Road, Mount Wellington, Auckland

This determination is concerned with the compliance of the building envelope to a 15-year-old house. The determination considers the authority's reasons for refusing to issue the code compliance certificate and whether the house complies with the requirements of the Building Code.

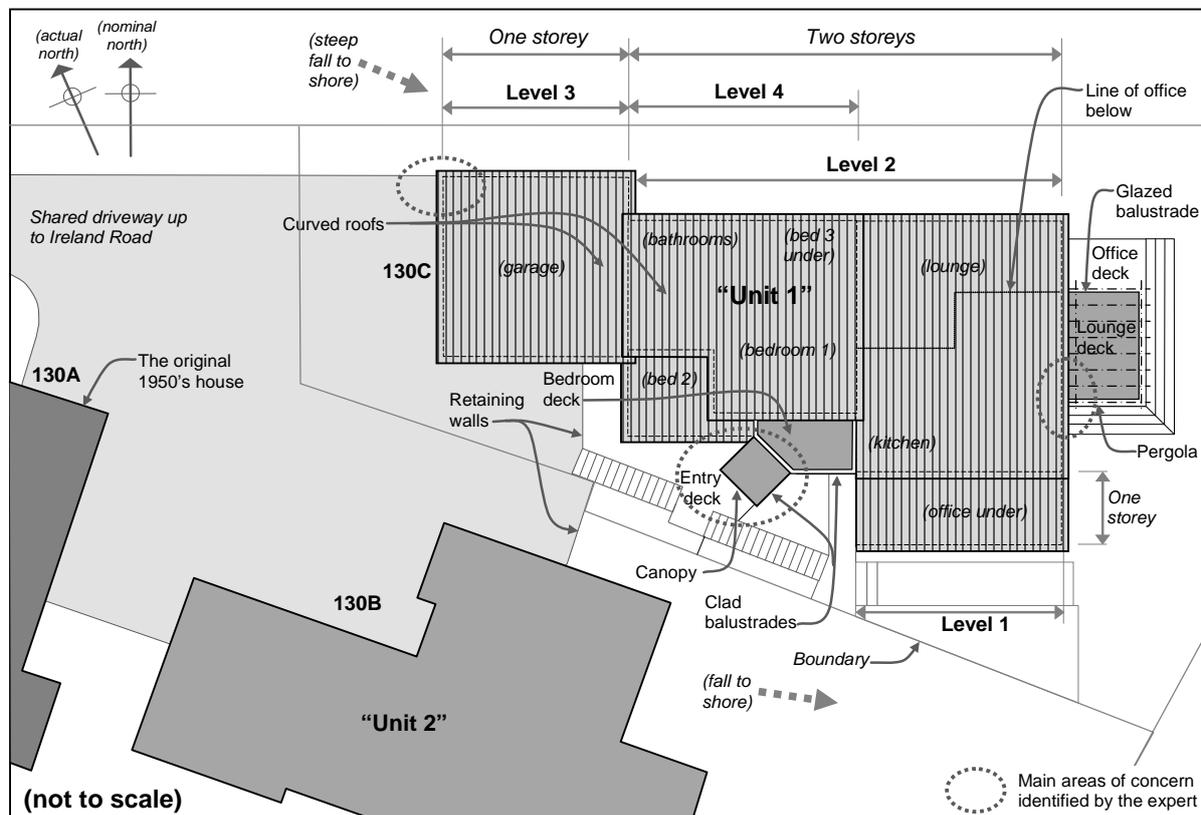
Figure 1: Approximate site plan (not to scale)

2.3 As shown in Figure 1, Unit 1 accommodates the following:

- Level 1 (the lower level): an office and toilet, with doors opening onto a ground level deck (“the office deck”) to the east.
- Level 2 (the mid level): the entry foyer, entry deck and entry canopy, two bedrooms and bathroom, and the lounge/dining/kitchen area opening onto a deck (“the lounge deck”) to the east.
- Level 3 (the garage): a single-storey garage, with stair access to Levels 2 and 3
- Level 4 (the upper level): the master bedroom and ensuite, with a small deck opening off the bedroom south wall (“the bedroom deck”).
