## Determination 2017/057

# Regarding the refusal to issue a code compliance certificate for a 20-year-old house with EIFS wall cladding at 15 Goldrush Lane, Rolleston

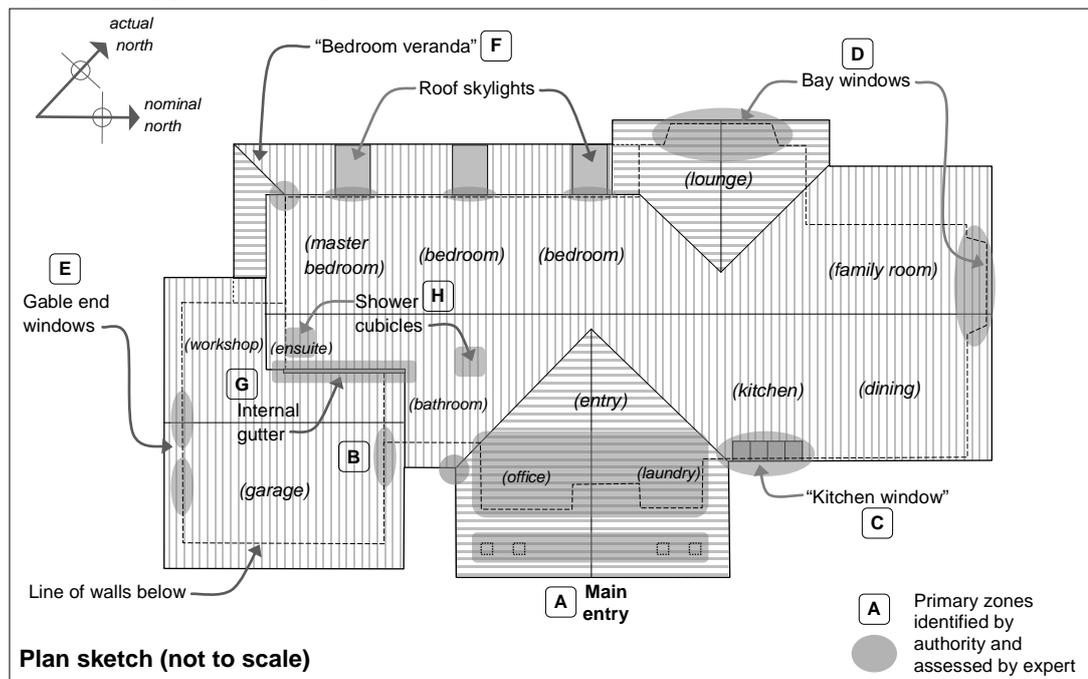
**Figure 1: Approximate plan**

2.2 As shown in Figure 1, the house accommodates the following:

- the main entry canopy and foyer in the central area of the east elevation
- to the north of the main entry; a laundry and the family room/dining/kitchen area and lounge opening onto a veranda to the west
- to the south of the lounge, two bedrooms and the master bedroom and ensuite, with the bedrooms opening onto a veranda to the west
- to the south of the main entry; an office and bathroom, with a garage/workshop at the southeast corner.

5.4.1 The expert inspected the external building envelope of the house, taking into account the age of the building work and the risks applying at particular junctions and intersections. (Refer to Figure 1 for locations of significant observations.)
