Determination 2017/060

Regarding the refusal to issue a code compliance certificate for 19-year-old additions and alterations to a house at 24 Godden Crescent, Mission Bay

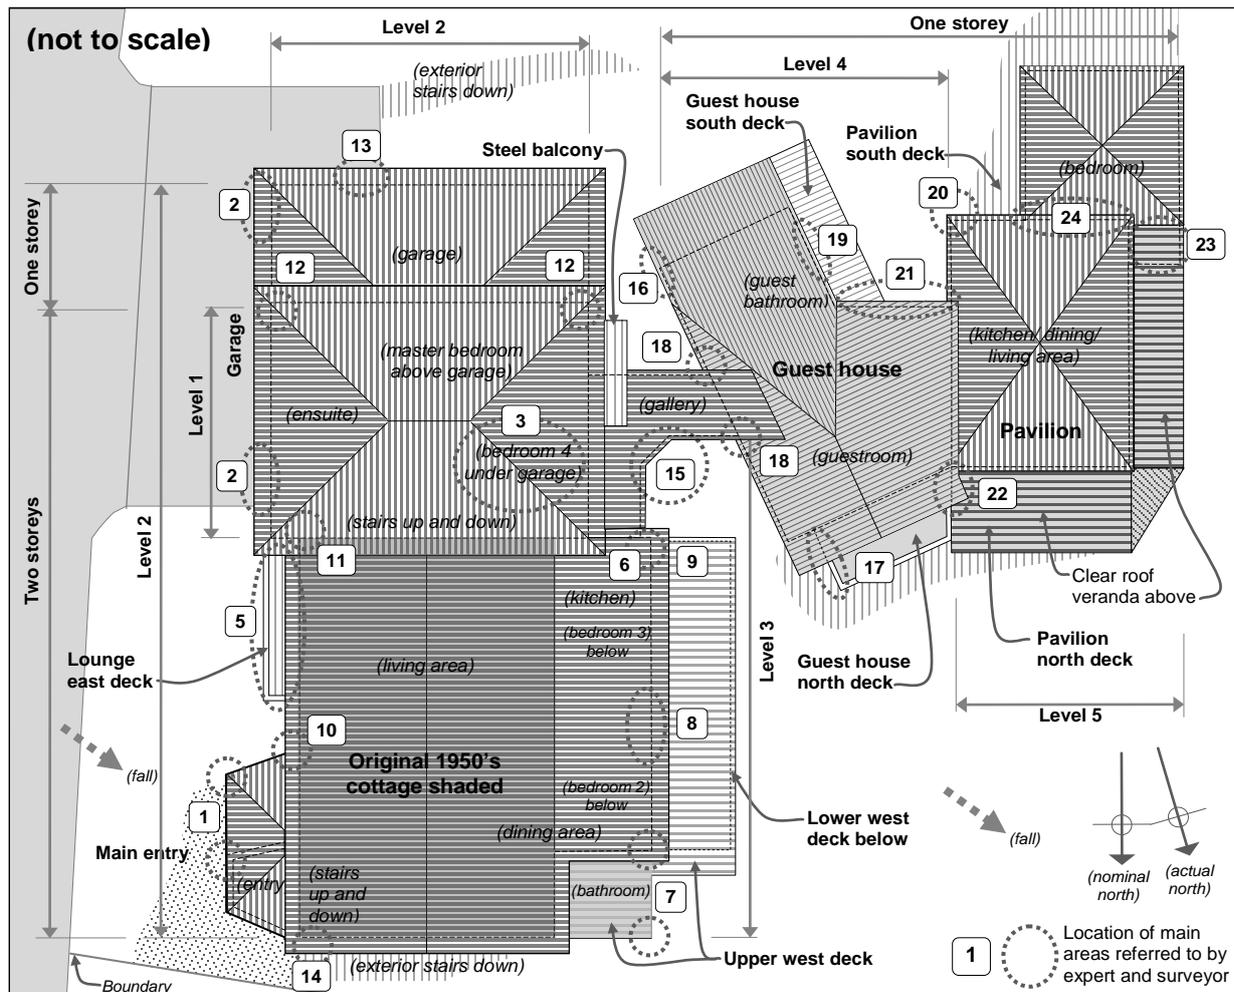
Figure 1: Approximate site plan

- 2.3 The extensions more than doubled the size of the original cottage; and the completed building is complex in plan and form, with a medium to high weathertightness risk. The building is shown in Figure 1 and includes additions and alterations to all elevations that have left no remaining visual indications of the original cottage.

3.7.3 The report considered the areas (in summary with location references shown in Figure 1 provided in brackets)

- 5.2.4 The expert observed a section of 'H1' treated timber in the gallery subfloor and saw low levels of decay despite exposure to regular long-term wetting. He therefore considered that wall framing used in the 1996 alterations is likely to be treated.
- 5.2.5 The expert considered the localities identified in photographs and various reports and commented on their weathertightness and durability performance, while noting proposals already made within earlier reports (see Table 1). Paragraph 5.3 to paragraph 5.8 summarise the expert's comments on relevant features of the external building envelope, with localities of areas identified in Figure 1.

6.2.4 Taking account of the expert's report, I consider that the following requires attention in regard to the 23 locations shown in Figure 1 and described in this determination⁸:
