## Determination 2018/020

# The refusal to issue a code compliance certificate for a 9-year-old house with rammed-earth walls at 107 Harleston Road, RD1, Sefton

This determination considers the compliance of the second stage of a house built with rammed-earth walls used as a structural element and as a cladding. The determination considers the compliance of the as-built work, the on-going maintenance of the rammed-earth walls, and whether the authority was correct in declining to issue a code compliance certificate for the work.

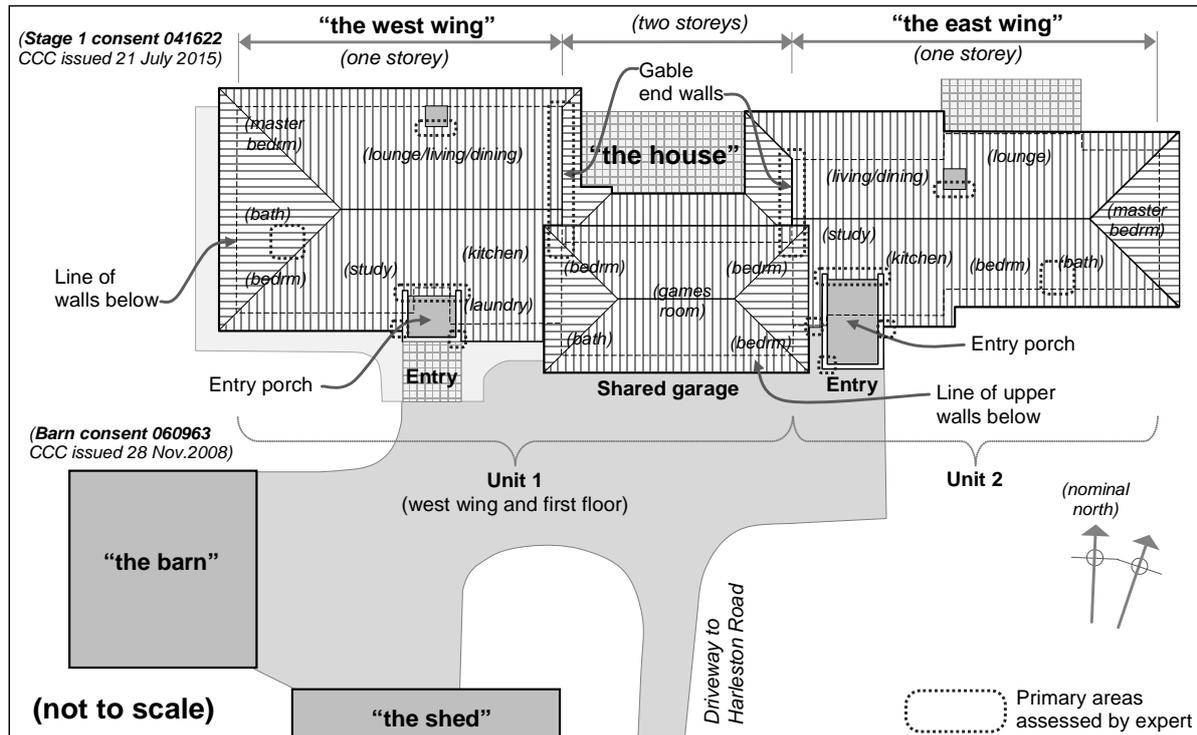
**Figure 1: Approximate plan**

2.1 The building work consists of a seven-bedroom house situated on a large level rural site in a medium wind zone for the purposes of NZS 3604<sup>5</sup>. The building was designed as two self-contained dwellings as shown in Figure 1, with:

- a single-storey two-bedroom unit to the east (“the east wing”)
- a single-storey wing extending to the west (“the west wing”), with the upper floor of the central section forming a five-bedroom unit
- a central four-car garage.

2.2 As shown in Figure 1, the house accommodates the following:

- The west wing and central upper floor (Unit 1):
  - entry porch and foyer to the south, a study to the west, laundry and store to the east, with stairs leading up to the upper floor
  - open plan living/dining/lounge opening onto paving to the north, with the kitchen to the south
  - master bedroom, bathroom and one bedroom to the west
  - in the upper floor, three bedrooms, bathroom and a central games room above the ground floor four-car garage.
- The east wing (Unit 2):
  - entry and foyer to the south, a study to the north, laundry to the west
  - open plan living/dining opening onto a veranda to the north, with the kitchen area to the south
  - a lounge with a projecting bay to the north, opening onto paving,

5.2.1 The expert inspected the external building envelope of the house, taking into account the age of the building work and the risks applying for particular junctions and intersections. (Refer to Figure 1 for locations of significant observations.)

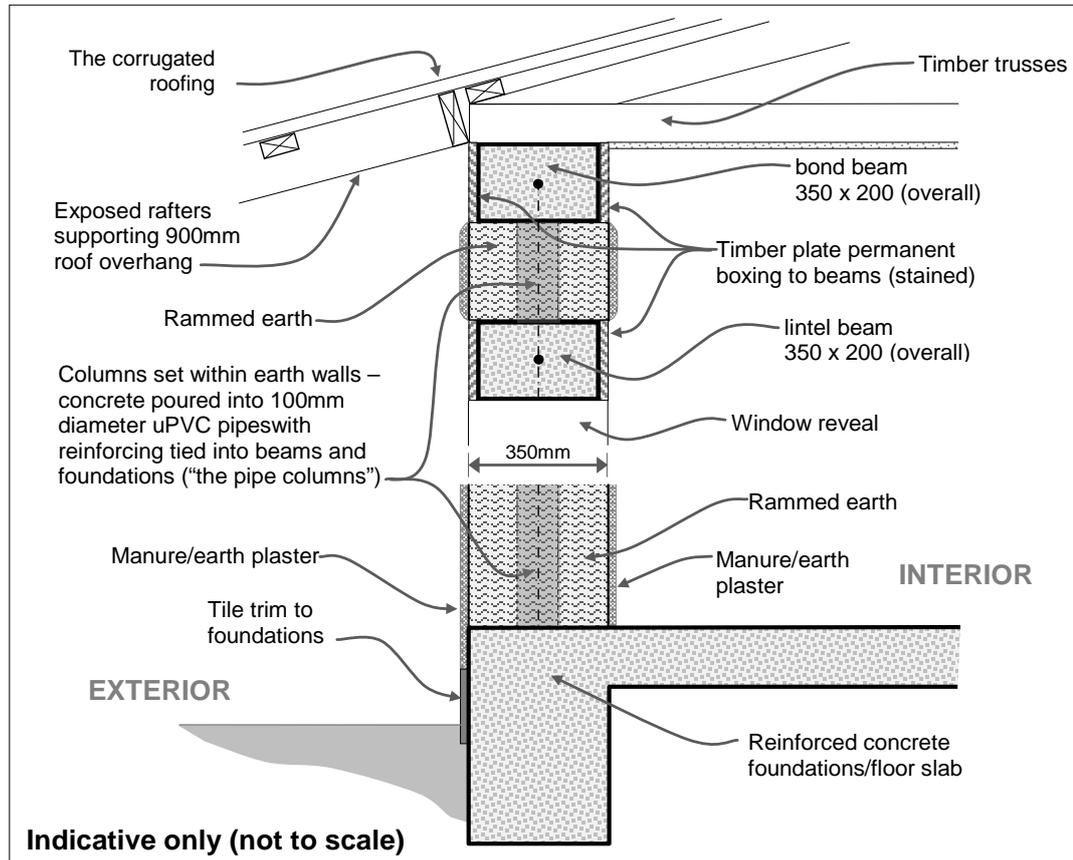
**Figure 2: Sketch of typical exterior wall**

- 2.5.1 The structural drawings call for the rammed-earth walls to include reinforced 'concrete columns' at all corners and beside all window and door openings. These are poured into PVC pipes set within the wall during erection of the rammed-earth ("the pipe columns"). Reinforced concrete lintel and bond beams are poured directly onto the rammed-earth and include permanent timber boxing as shown in Figure 2.

- 2.6.3 In the entry porches, 50mm thick AAC panels are fixed into 22mm deep horizontal metal top hat sections, which are in turn fixed through the building wrap to the framing. The AAC cladding is finished with a proprietary mesh-reinforced plaster system to form a monolithic finish.

for the house (see Figure 2) indicate that the cracking shown in some photos ‘is of minor concern.’
