Determination 2018/026

Regarding the issue of a notice to fix in respect of building work undertaken without building consent at 28 Tasman View Road, Bethells Beach

Summary

This determination considers a notice to fix issued for the rebuilding, without a building consent, of a small extension or lean-to attached to a house. The matter turns on whether the components or assemblies replaced in the rebuilding of the structure were in the same position such that they were exempt under Schedule 1 from the requirement for a consent, and whether the notice to fix was correctly issued.

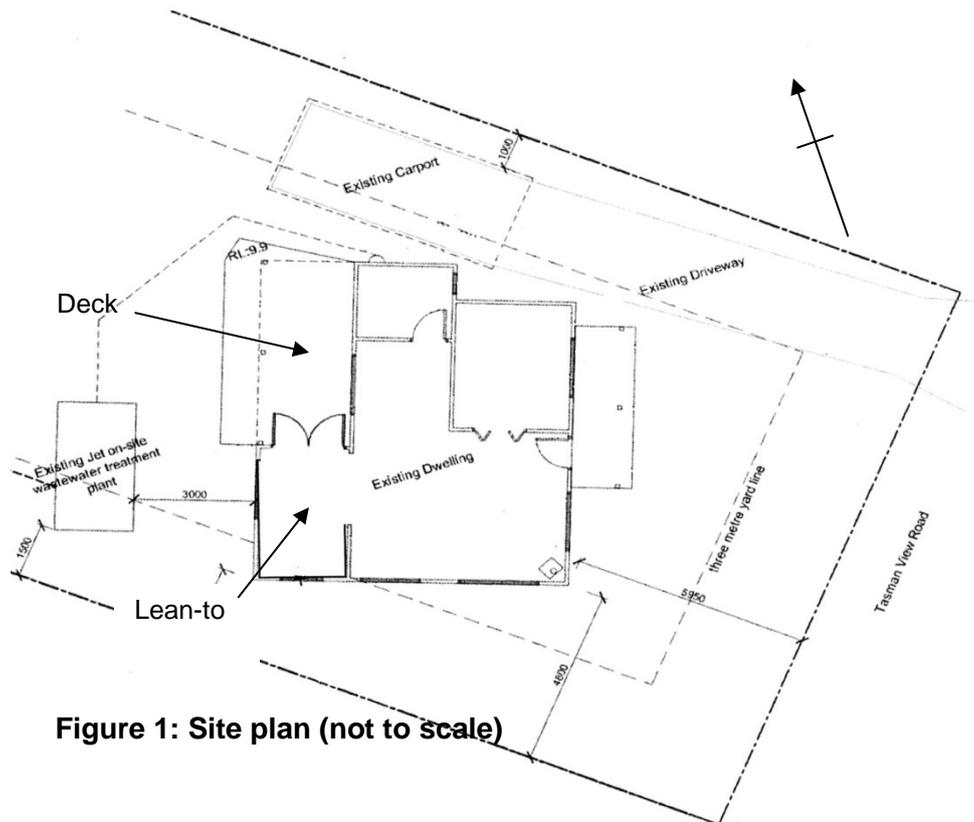
Figure 1: Site plan (not to scale)

- 2.1 The building is an existing single level bach-style building which was originally constructed circa 1970³ with light timber framing and pile foundations. The building work considered in this determination concerns the reconstruction of a room that was originally constructed prior to 1991 without a permit, as an extension to the living area (see Figure 1).

- 2.2 The building work at issue is a room which extends off the living area and opens onto the deck. It is approximately 3.5x2m, with corrugated iron roofing, and fibre cement sheet external wall cladding. In this determination I use the term 'lean-to' to describe the structure, although I acknowledge that this term has certain limitations. For example, a 'lean-to' generally has its own roof abutting an external wall of a house. In this case, while the original lean-to possessed that characteristic, the rebuilt lean-to does not (see paragraph 4.2.18).

The second bullet point at paragraph 1.2 (below) should have referred to “Auckland Council”, not “Auckland City Council”. Also, the areas depicting the lean-to and deck in the site plan in Figure 1 (on page 2) were mislabelled. These errors have been corrected.
