Determination 2019/032

Regarding the refusal to issue a code compliance certificate for a 21-year-old commercial building at 2 Northpark Drive, Te Rapa, Hamilton

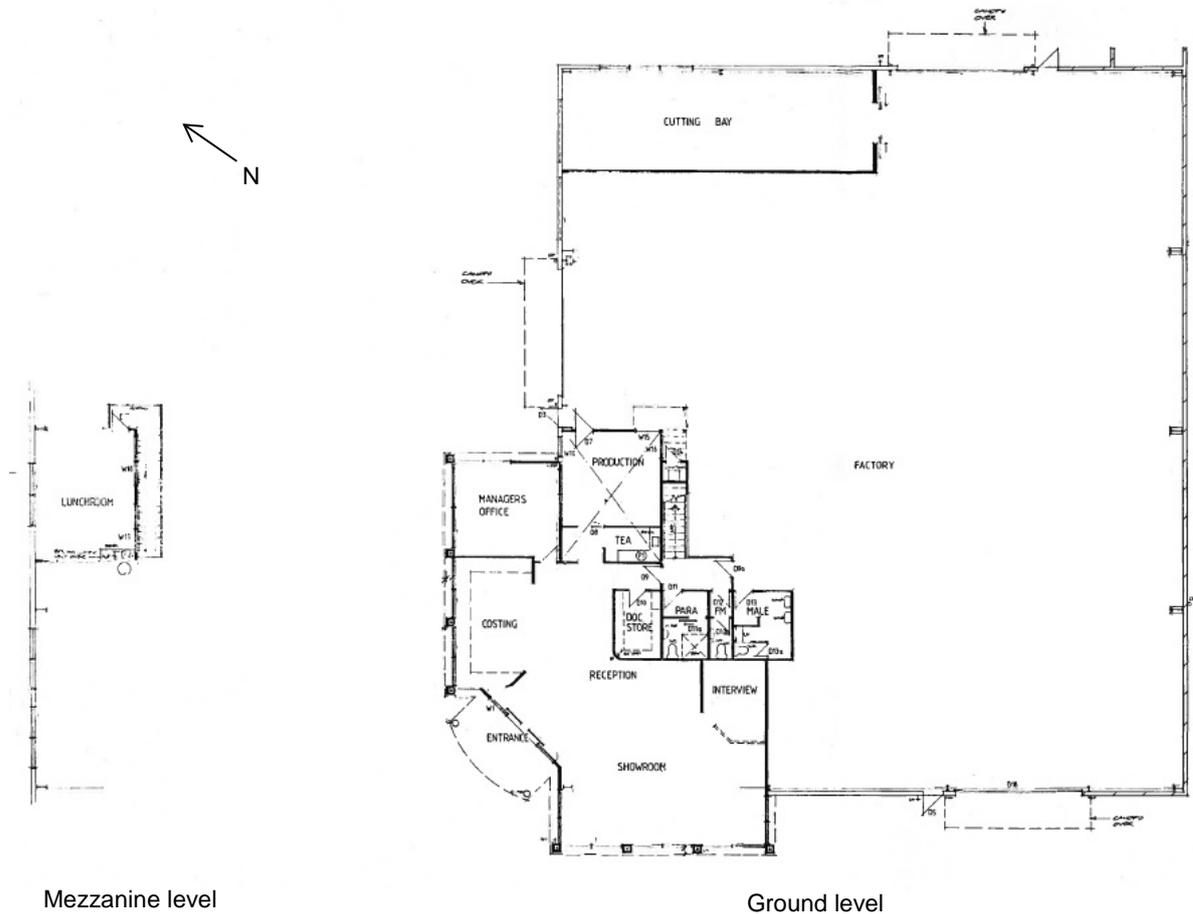
- 2.1 The building is an approximately 28m long by 30m wide detached building on a large level site. The building is 6m high at the eaves.
- 2.2 As shown in Figure 1, the building includes on the ground floor a factory, with adjacent rooms including a showroom, office, and toilets. The mezzanine level contains a lunch room.

Figure 1: Floor plan of the building as consented (not to scale)

- 2.3 The structure consists of specifically engineered steel portal frames and a concrete slab foundation. Blockwork and steel framed walls form the external walls, and the internal walls are timber-framed. The external walls are mostly clad with direct-fixed metal sheet cladding, with the lowermost 2m clad with direct-fixed rusticated cedar weatherboards.
- 2.4 The main roof is constructed from steel members forming a gable roof with a 5° pitch and is clad with metal long run roofing. The lower level timber trussed roofs, on the south and west side of the building, also have a 5° pitch and are clad with metal long run roofing. The rounded canopies on the north and west side of the building are also clad with metal long run roofing.
