Determination 2020/014

Regarding the authority's refusal to grant an amendment to a building consent for a revised timber remediation methodology and window joinery flashing system at 42 Stanmore Bay Road, Auckland

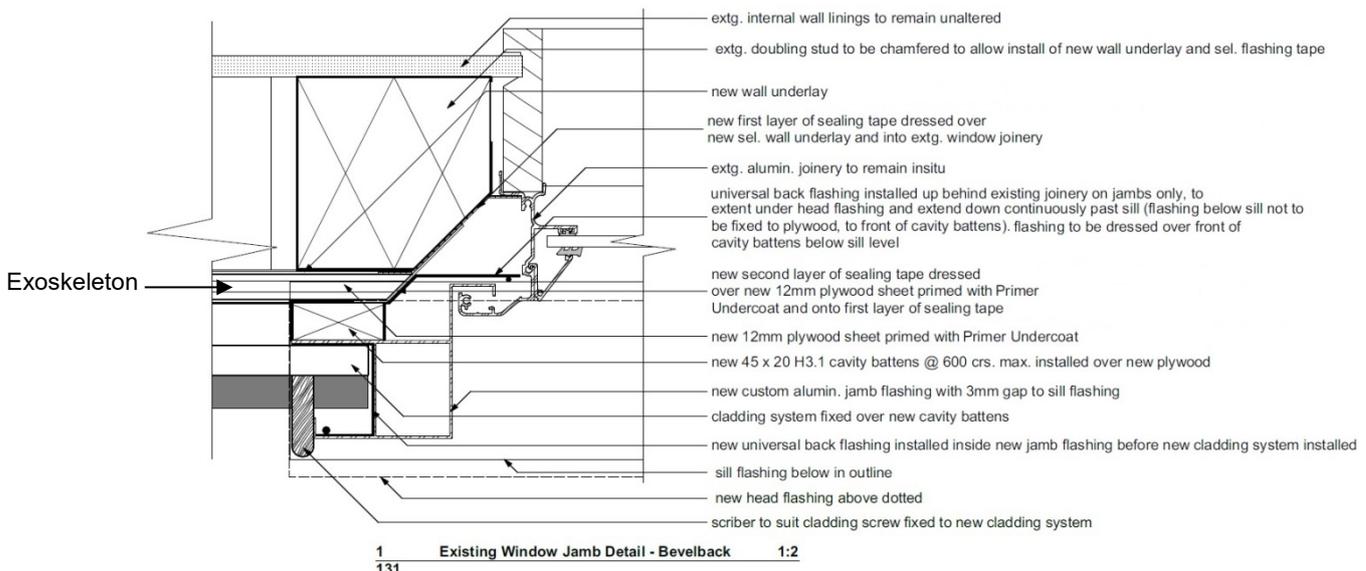
Figure 1: Jamb detail showing the flashing system (not to scale)

- 2.2.1 The existing windows are to be left in place (instead of being removed and reinstalled as per the original building consent) with a custom recessed window flashing system proposed ("the flashing system") to be installed around the joinery. To install the flashing system without removing the joinery head, sill, and jamb timber framing is proposed to be chamfered back (refer Figures 1 and 2).
- 2.2.2 The flashing system is shown below:

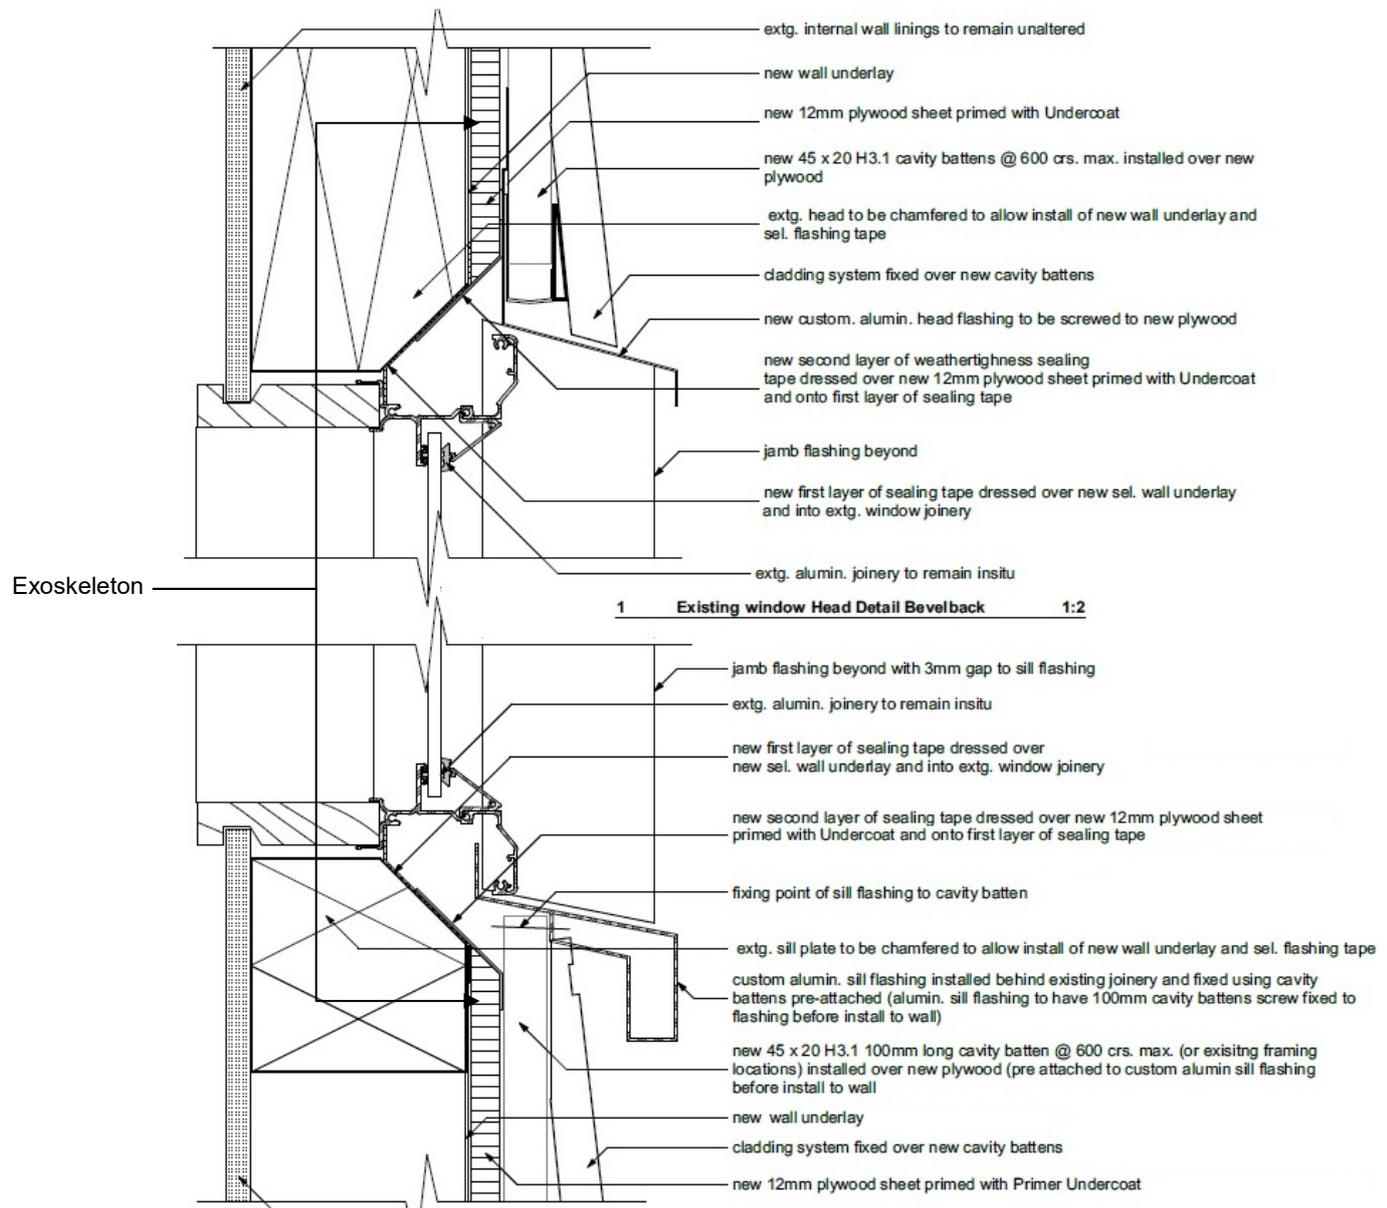
Figure 2: Head and sill detail showing the flashing system (not to scale)
