Determination 2023/027

The pathway to demonstrate compliance with clause E2 of a proposed direct-fixed plywood cladding system on a building at 13 Pendene Place, Forrest Hill, Auckland

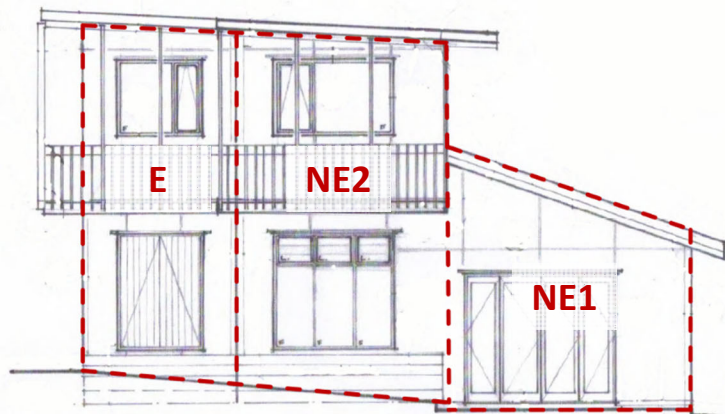
Figure 2. The north-east elevation

- 4.22. The assessment approach that should be adopted for a particular building is “a question of judgement” based on the complexity of the building’s design. While the parties debated the best approach to use, both provided assessments using the wall face approach. This determination also uses this approach as I am of the view that it most accurately identifies the risks of this particular building’s design.
- 4.23. Figures 2-5 on the following pages show the various elevations of the owner’s workshop addition, with the individual wall faces of each elevation, and the notation I will use to refer to them. Note that because elevations E and S are at an angle, they appear on two elevations each.

- 4.24. The parties agree over the risk scores that should apply for the building's wind zone, number of stories, and eaves width. The factors that the parties dispute are the levels of risk posed by the roof/wall intersection designs and the deck designs.
