Determination 2025/017

An authority's decision to grant a building consent under section 72

11 Maruia Place, Te Puna, Tauranga

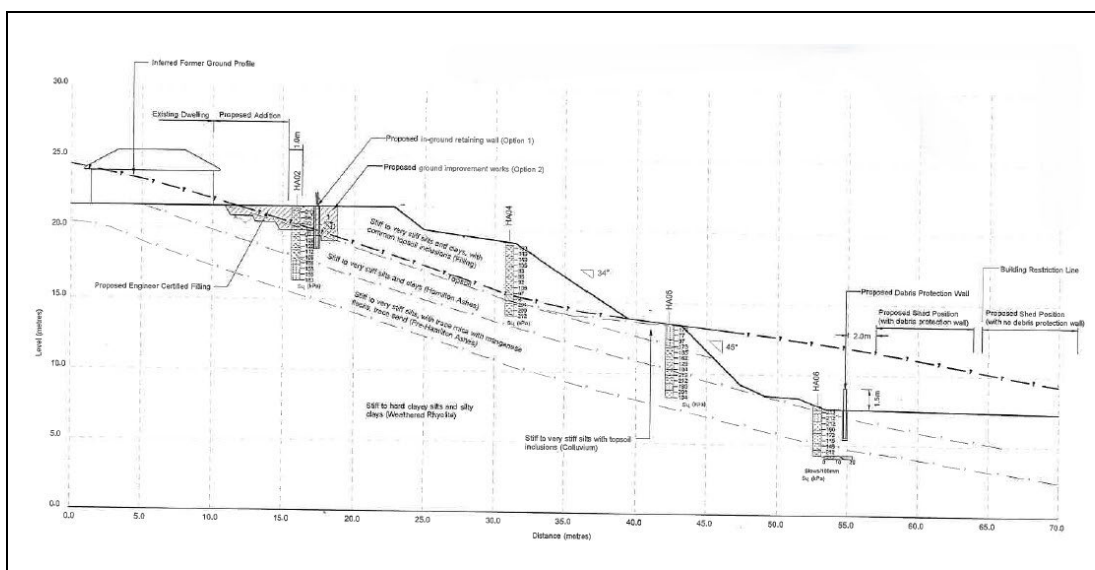
2.12. Both drawings show the dwelling additions (as proposed at that time) sited partially over the pre-existing fill (by around 4 metres).¹² The northern perimeter of those additions is shown approximately 8 metres away from the top of the slope. The shed (as proposed at that time) is shown approximately 3.5 metres away from the pre-existing batter at the bottom of the slope.

Figure 1: Cross section of proposed building sites and sloping topography

2.11. The report includes a site plan, and cross section of the proposed site and the slope. These drawings show an area of fill (“the pre-existing fill”) which appears to have been placed directly over the former ground. It is present from the perimeter of the existing dwelling, extending about 12 metres to the top of the slope, and then downslope a further 16 metres approximately. From there, the remaining slope is a cut made by earthworks, spanning about 10 metres, with several layers of differing subsoils exposed.
