# Determination 2025/023

## Regarding the issue of three code compliance certificates and compliance of items of building work

### 3 Sideys Road, RD 24, Southburn, South Canterbury

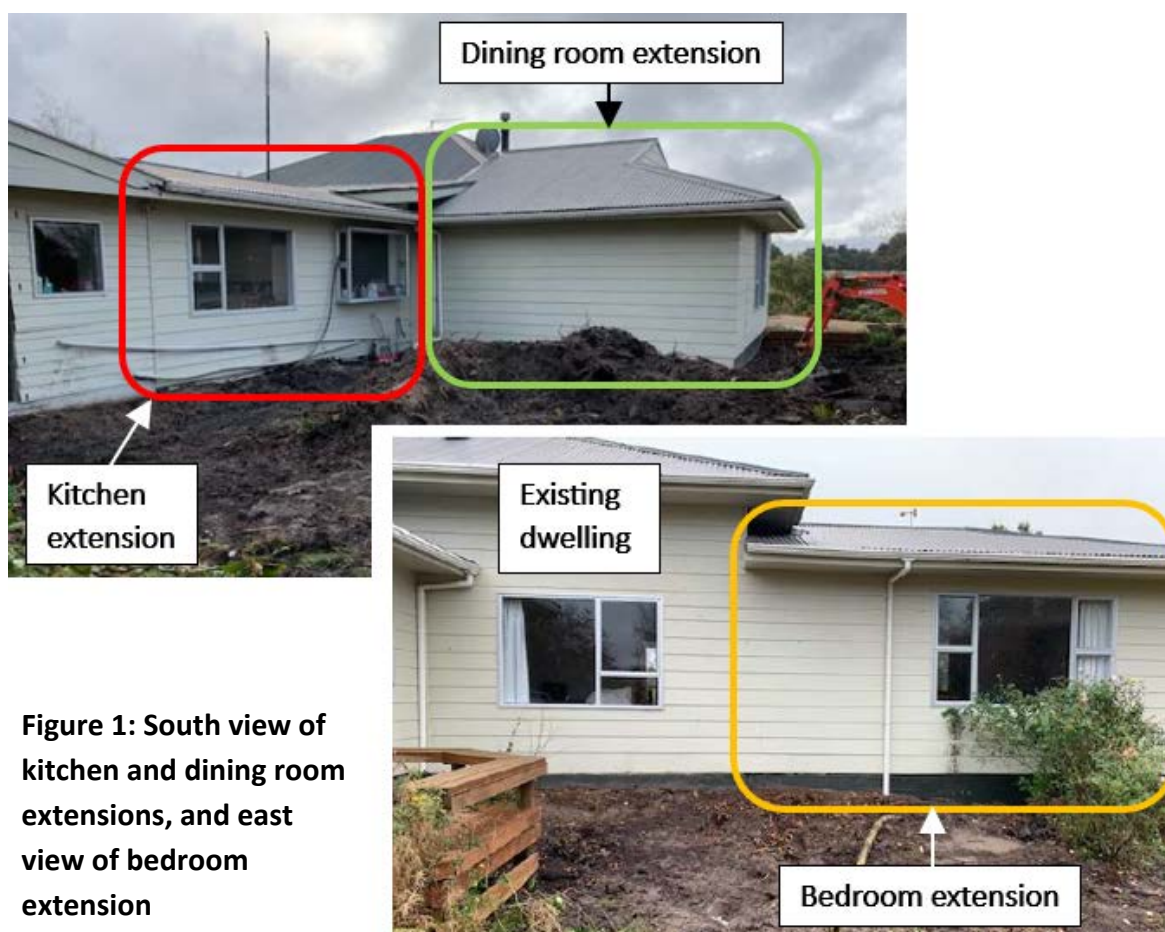
**Figure 1: South view of kitchen and dining room extensions, and east view of bedroom extension**
