# Determination 2026/036

**Regarding the compliance of a modular dwelling with  
Clauses B1, B2, E1, E2, E3, and G9**

**4/1526 Waimea Highway, Mandeville**

This determination considers the compliance of a modular dwelling constructed partly offsite and partly at the owners' property under two separate building consents granted by two authorities. The determination discusses the compliance of the as-built work with several clauses of the Building Code, primarily relating to the dwelling's structure, weathertightness, gutters, bathroom linings, and electrical fixtures.

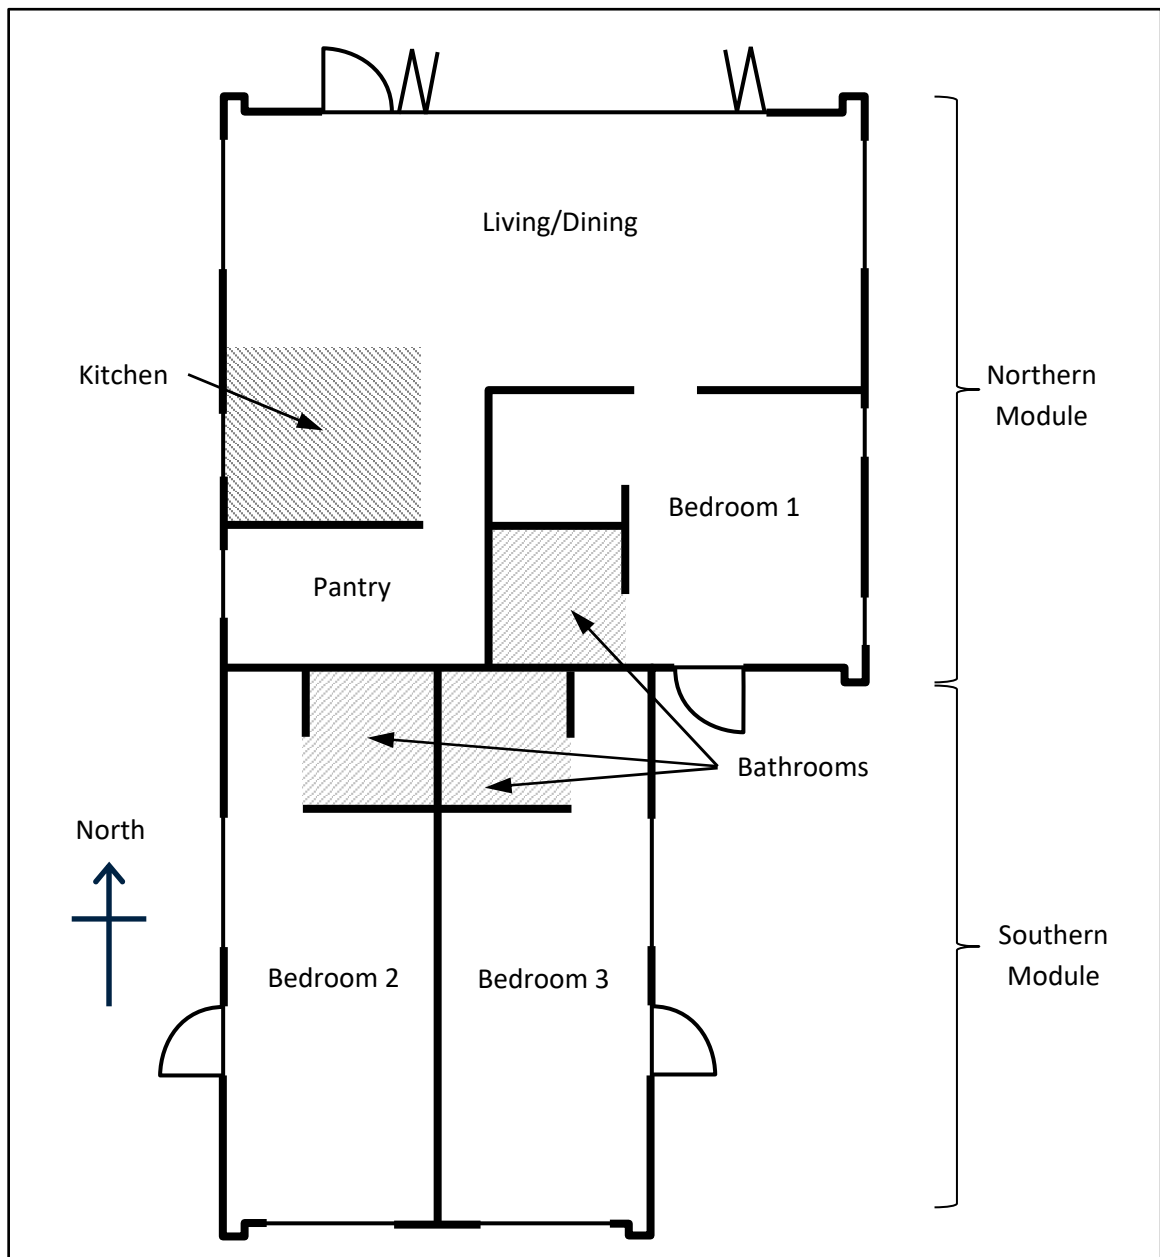
**Figure 2: Layout diagram of the dwelling. Not to scale.**

- 2.1. The owners' building is a 117.6m<sup>2</sup> floor area single storey detached dwelling ("the dwelling"), located on a flat site in Mandeville. The dwelling is located to the north-western corner of the site, set back approximately seven metres from the northern boundary to an adjoining airfield. The approved plans state that the dwelling is located in a high wind zone<sup>5</sup>.
- 2.2. The dwelling comprises two adjoining modules on timber foundations. The northern module contains an open-plan living, dining and kitchen area, with an adjoining walk-in pantry, and one bedroom with an ensuite bathroom. The southern module contains two bedrooms, each with an ensuite bathroom. There is no internal access

between the modules or between the two bedrooms in the southern module. There are external doors in each of the three bedrooms, the kitchen, and the living area.
