Leaky Homes Financial Assistance Package (FAP) Repair plan example

EXAMPLE REPAIR PLAN
123 EXAMPLE STREET
SUBURBIA
AUCKLAND, 9999

EXISTING FLOOR PLAN & PROPOSED FLOOR PLAN
SCALE: 1:100 @ A3

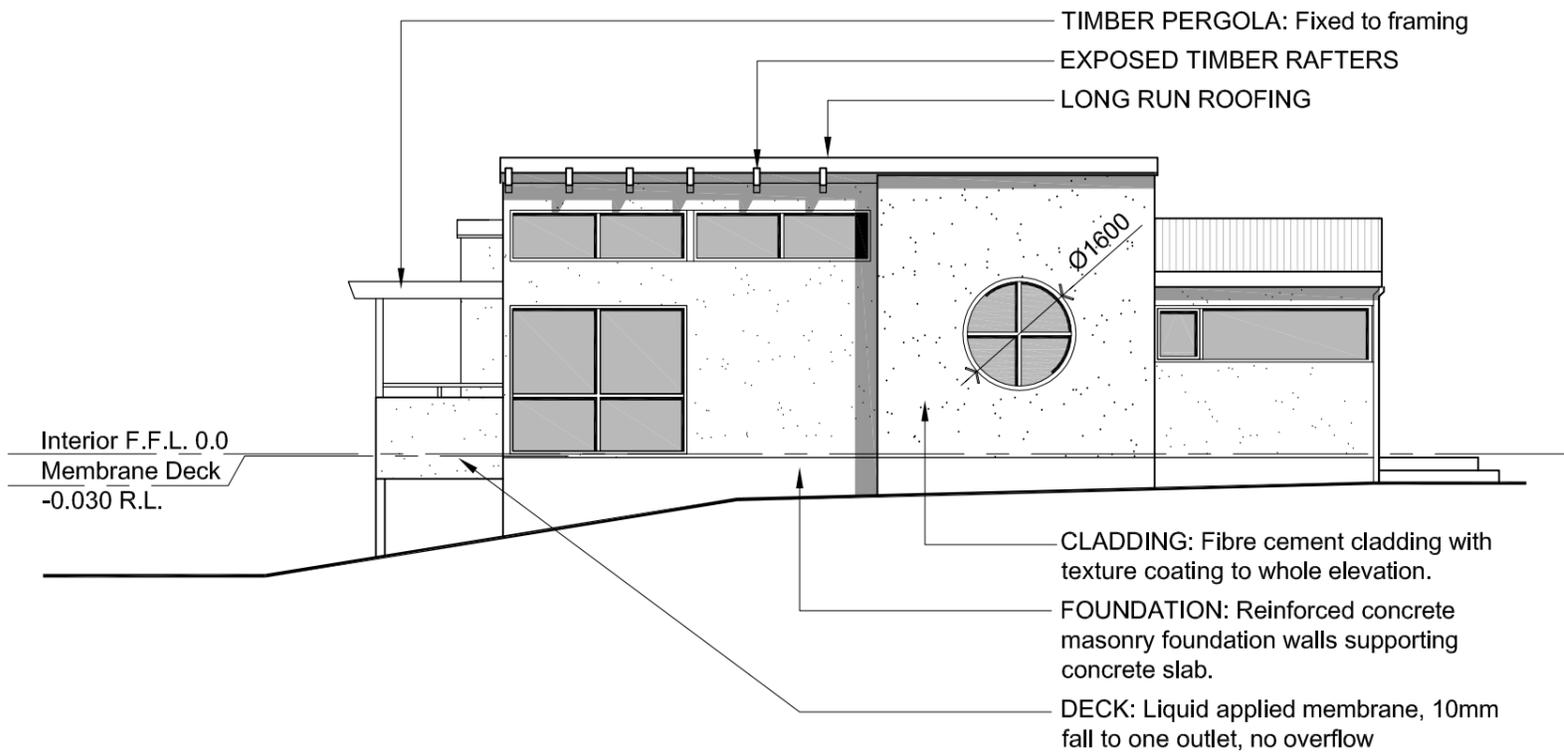
1 | EXISTING North Elevation

EXAMPLE REPAIR PLAN
123 EXAMPLE STREET
SUBURBIA
AUCKLAND, 9999
EXISTING + PROPOSED
ELEVATIONS - N / E
SCALE: 1:100 @ A3

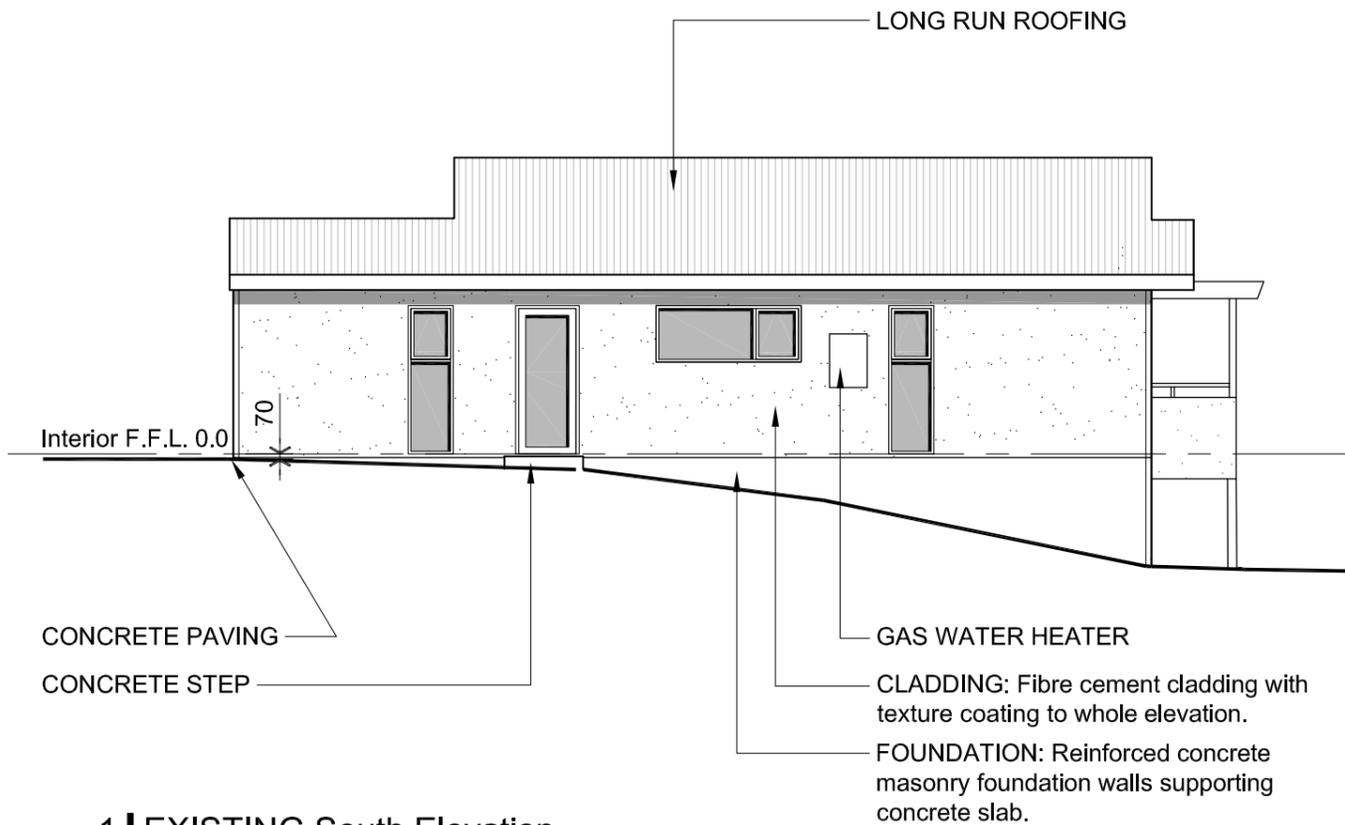
1 | EXISTING South Elevation
1.01 | 1:100

EXAMPLE REPAIR PLAN
123 EXAMPLE STREET
SUBURBIA
AUCKLAND, 9999
EXISTING + PROPOSED
ELEVATIONS - S / W
SCALE: 1:100 @ A3
