Part A: Technical guidance

2. Foundation assessment criteria and approaches

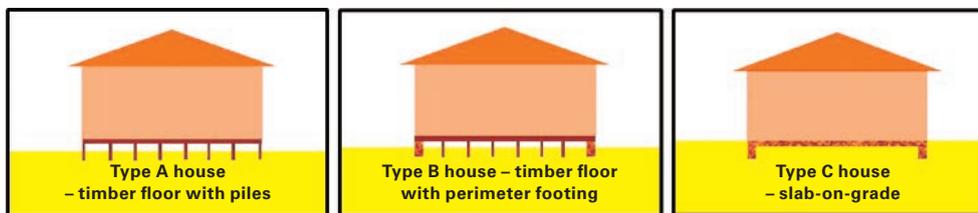
Figure 2.1: Dwelling foundation Types A, B and C

Three broad groups of dwellings have been used in the subsequent sections of this document to describe dwellings on the flat, as represented in Figure 2.1.

The Type B and C house foundations have been further subdivided into those supporting light- and medium-weight claddings (B1 and C1) and those supporting heavy claddings such as brick veneer (B2 and C2) (see Table 2.1).

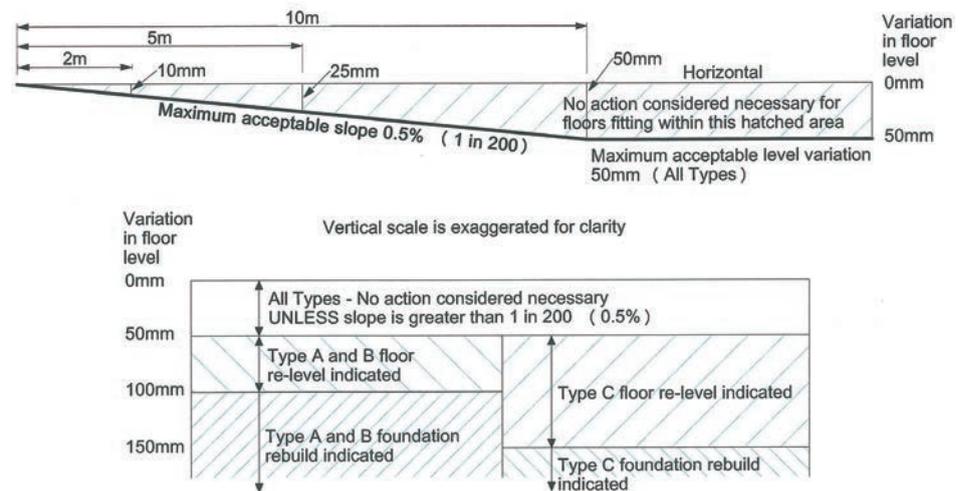
Figure 2.2: Diagrammatic representations of slope and overall variation limits from Table 2.3

The indicator criteria contained in Table 2.3 can be used to indicate first whether a house is likely to need releveling, and then secondly, if it does, whether a relevel, a foundation rebuild or a house rebuild is likely to be required.

The indicator criteria stated in column 2 of Table 2.3 are suggested threshold values – below these it is considered that no action is required to relevel or rebuild the floor. Where these thresholds are exceeded, the recommended process to follow will be determined by how much they are exceeded. This means that as long as the thresholds in column 3 are not exceeded, a relevel should be able to be undertaken. If the limits in column 4 are exceeded a foundation rebuild should be an option. Finally, if the damage to the superstructure is uneconomic to repair, because the house has collapsed off the piles for example in floor Types A and B, then a complete house rebuild is indicated. If the floor profile fits within the criteria in column 3, the expectation is that the releveling processes will result in a floor that is as near as reasonably practical to level and certainly within the criteria stated in column 2. These are the maximums of desired slope and differential displacement, and tighter tolerances should be targeted during releveling processes. Some insurance policies may require a higher standard of reinstatement than suggested by column 2 of Table 2.3.

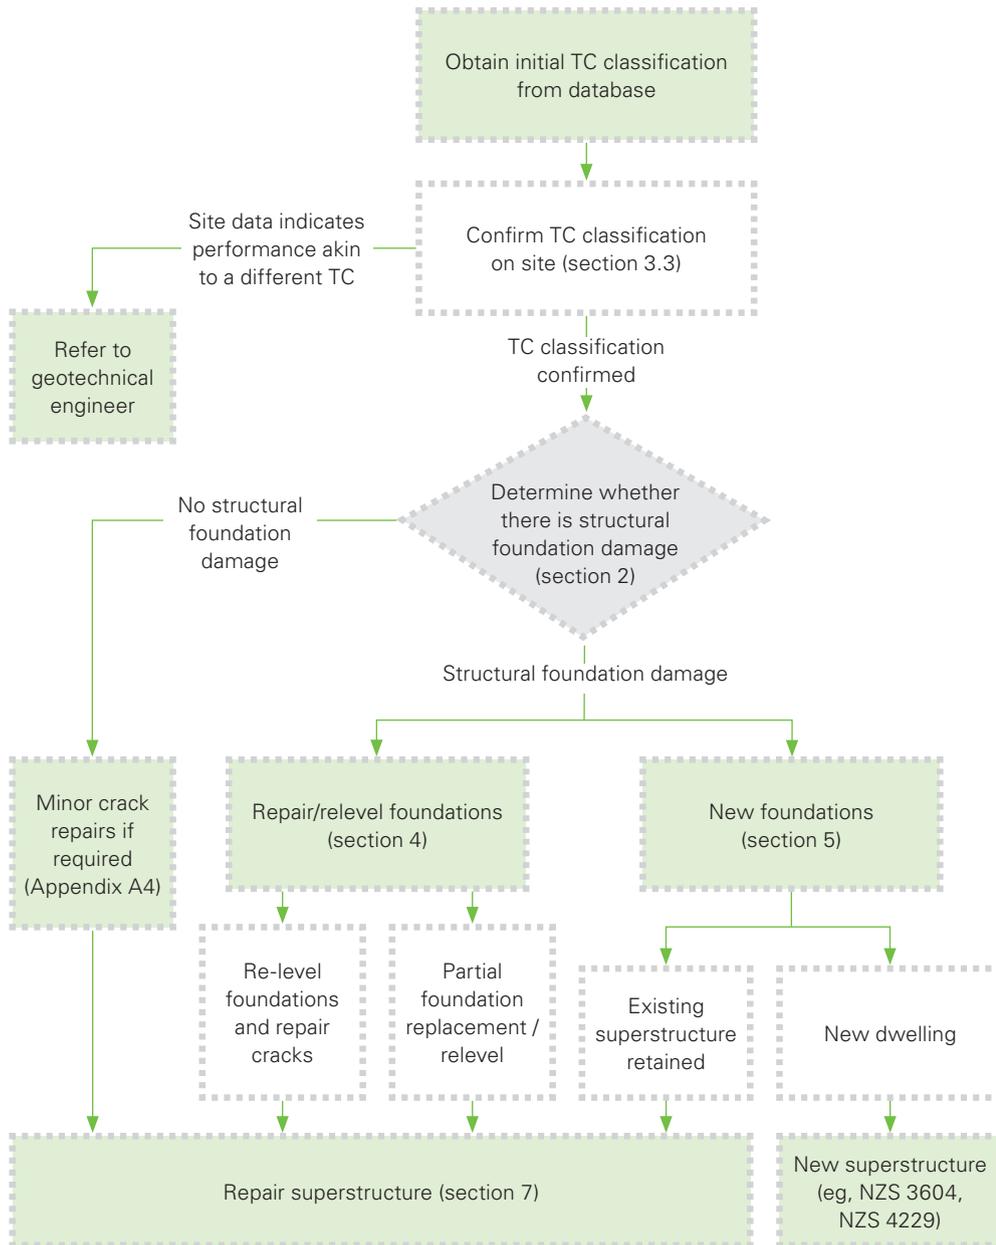
Figure 3.3: Determining the level of repair/rebuild required for Green Zone houses on the flat

December 2012
 Figure 3.3 has been amended to introduce the option of a partial repair of foundations.

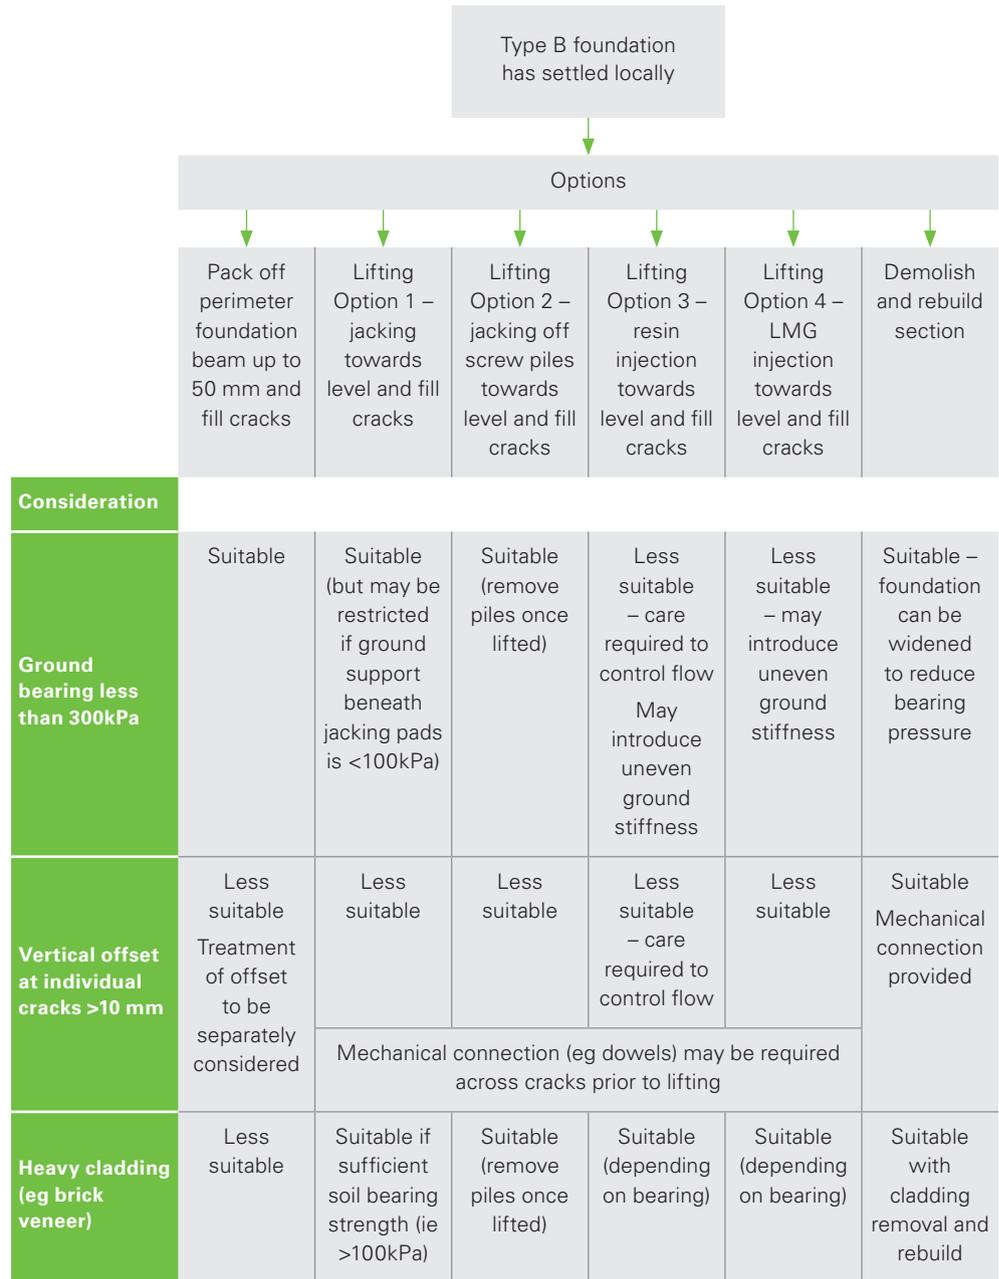
Figure 4.2: Options for addressing localised settlement of Type B perimeter concrete foundation beams (eg corners)

Figure 4.2 provides suggested options for repair or partial replacement for Type B foundations in TC1 and TC2 where only a small proportion of the foundation has settled.

Note: Lifting Options 1 to 4 are presented in Appendix A1.

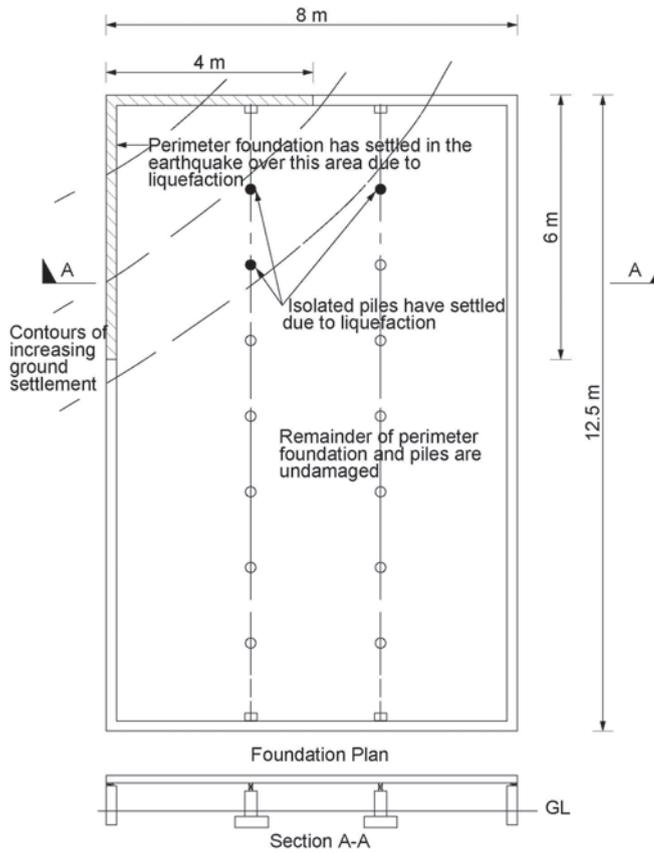
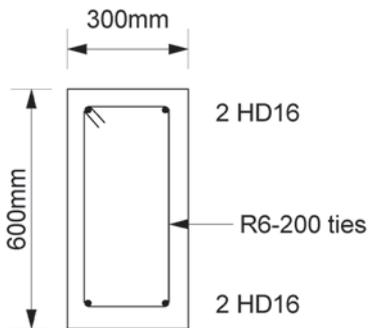
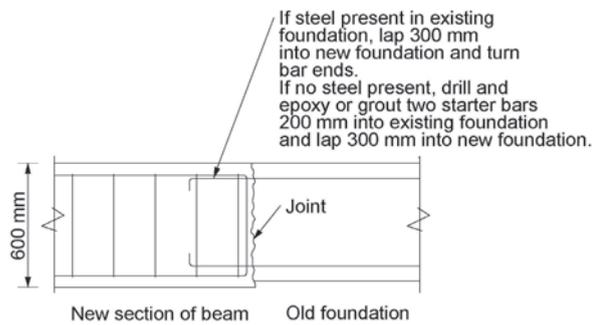
Figure 4.2a: Example of a partial foundation wall replacement

Figure 4.2a shows a typical plan of such a Type B foundation where settlement of only part of the foundation wall has occurred. In this scenario, a limited number of piles are also likely to have settled, and packing or replacement will be required, depending on the amount of settlement.

Plan and cross-section

Cross section through an enhanced foundation wall
Note that an increase in height will strengthen and stiffen the beam.

Section through enhanced foundation wall

Elevation of suggested joint between old and new foundation

Note: Reinforcement details as per Figure 4.2a

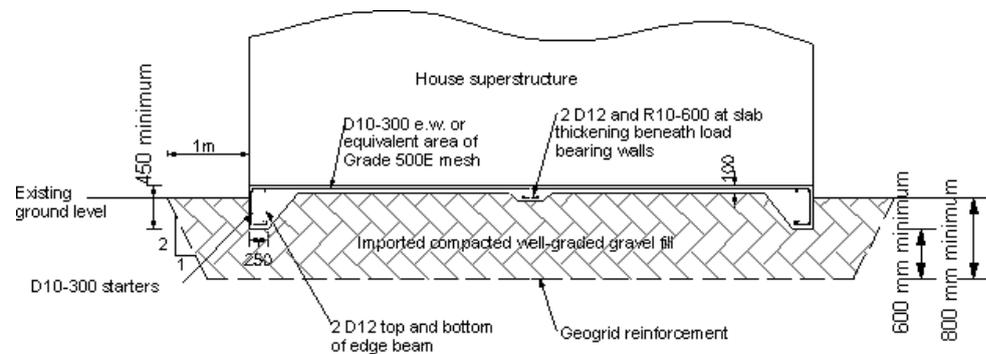
Figure 5.5: Enhanced foundation slab – Option 1

Several options may be used, but each has limitations that must be recognised. In all options the NZS 3604 ground clearances adjacent to the house foundation must be complied with. Note that for clarity the damp proof membrane (DPM) has not been shown in these representative details.

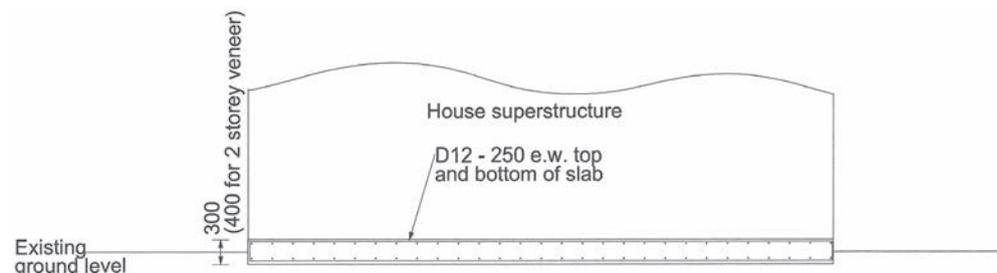
Figure 5.6: Enhanced foundation slab – Option 2

Option 2 – Construct a thick slab foundation over the existing soil.

Note: NZS ground clearances adjacent to house foundation must be complied with. DPC omitted for clarity.

The ground immediately beneath the slab must have a minimum geotechnical ultimate bearing capacity of 200 kPa, or the slab should be subject to specific engineering design (see section 3.4.1). **Note: The thickness needs to increase to 400 mm for two-storey heavy-weight (brick veneer) construction with either a heavy or light roof cladding.**

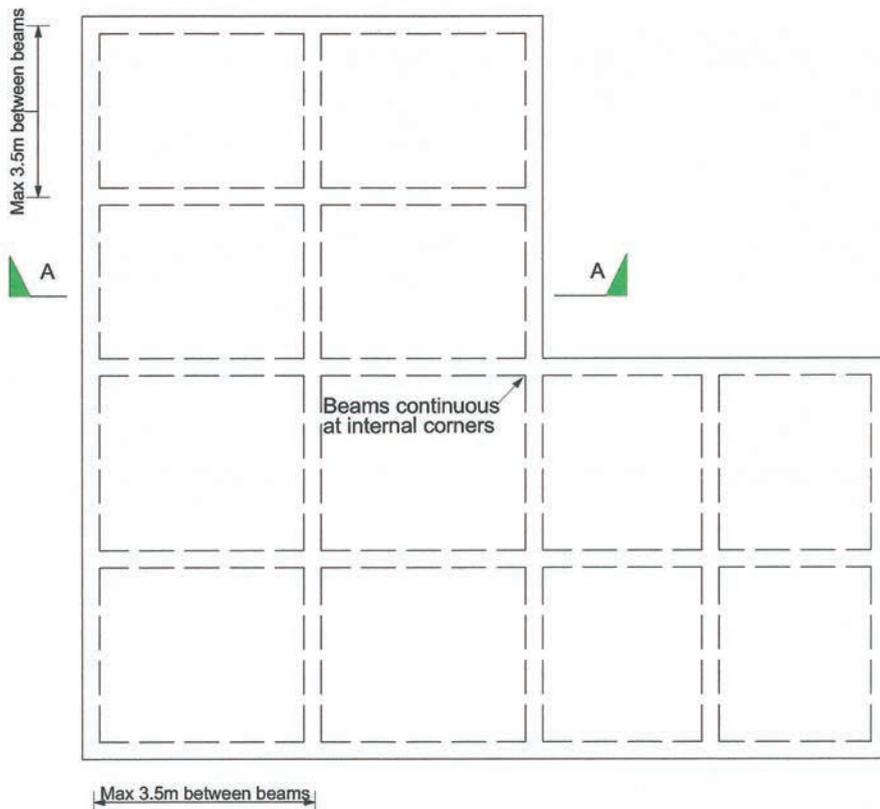
Figure 5.7: Enhanced foundation slab – Option 3 plan

Note: Reinforcing details are not sufficient for two-storey heavy-weight cladding (brick veneer) with a heavy roof but can be used for a two-storey heavy-weight cladding with a light-weight roof.

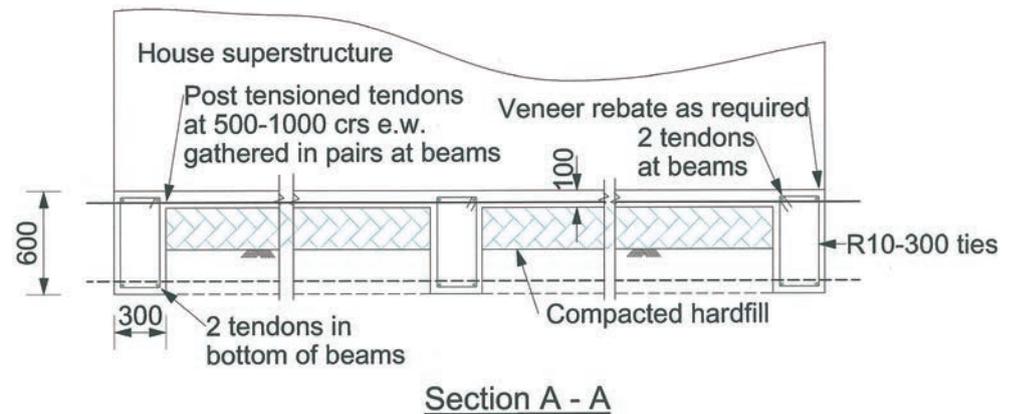
Figure 5.9: Enhanced foundation slab – Option 3 variation with post tensioning

Note: Post tensioning strands are either 12.9 mm or 15.2 mm diameter and factory coated with grease inside an HDPE sheath, giving an overall outside diameter of 17 to 20 mm respectively. Strands are tensioned to provide 0.5-1.0 MPa compressive stress in the concrete.

For both Option 3 variations, it may be easier and more economical to construct the concrete foundation by replacing the compacted hardfill and soil beneath the slab down to the underside of the beams with polystyrene pods.

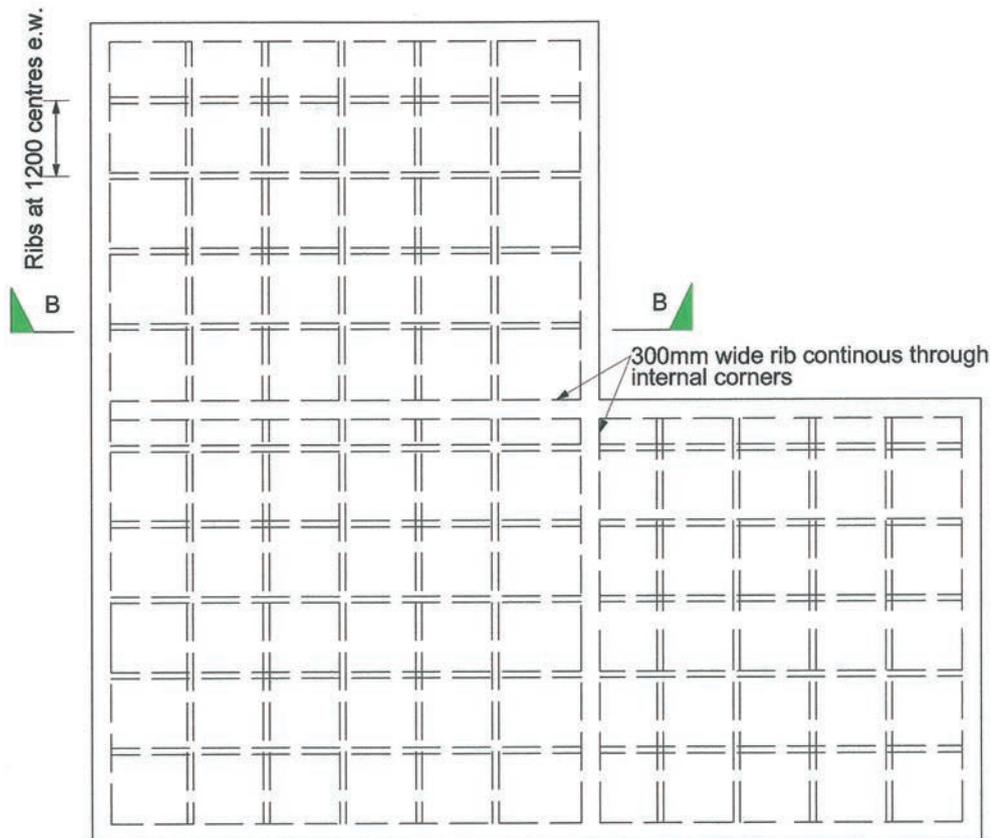
Figure 5.10: Enhanced foundation slab – Option 4 plan

Note: Reinforcing details are not sufficient for two-storey heavy-weight cladding (brick veneer) with either a heavy or light roof.

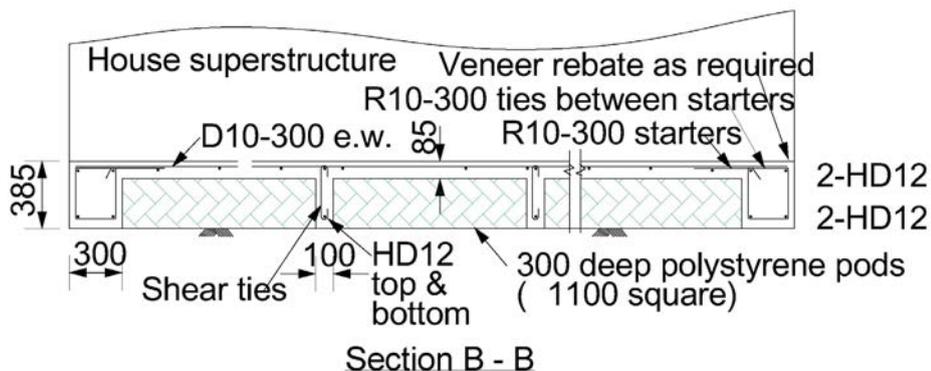
Figure 5.11: Enhanced foundation slab – Option 4 cross-section

The ground immediately beneath the polystyrene and ribs must have a minimum geotechnical ultimate bearing strength of 200 kPa, or the system should be subject to specific engineering design (refer to section 3.4.1). Shear ties in accordance with NZS 3101 are required in the ribs.

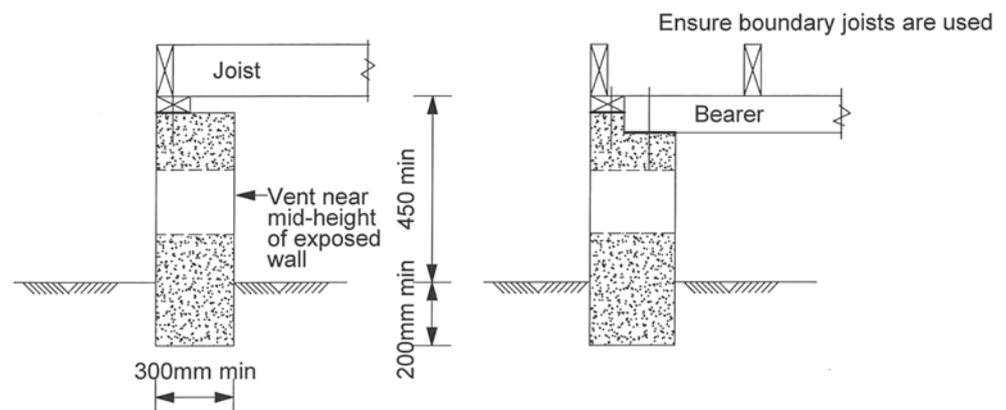
Figure 5.12: Timber floor with perimeter walls

The vents in the foundation wall must be positioned near the middle of the wall below the top reinforcing bar, and not notched out of the top of the wall as is common in older houses in Christchurch.

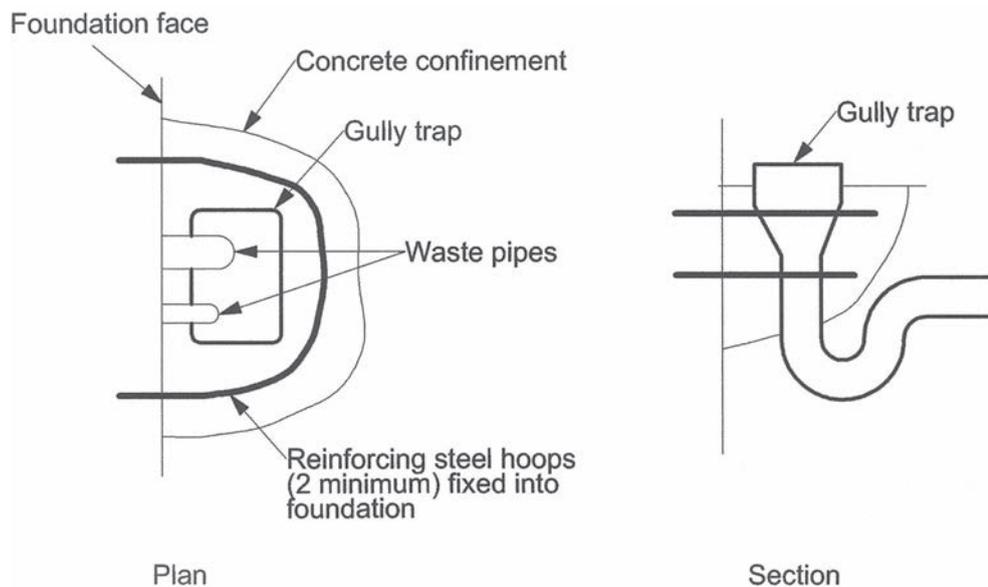
Figure 5.15: Restraint of gully trap

Plumbing codes require at least one gully trap on the perimeter of a house. Invariably, waste pipes pass through the foundation slab and discharge into the gully trap from above it. Sometimes the waste pipes enter via the side wall of the gully trap. It is recommended that the gully traps be encapsulated in concrete which is tied to the house foundation (hooped reinforcing bars), preventing differential movement should there be ground spreading or settlement adjacent to the foundation (see Figure 5.15).

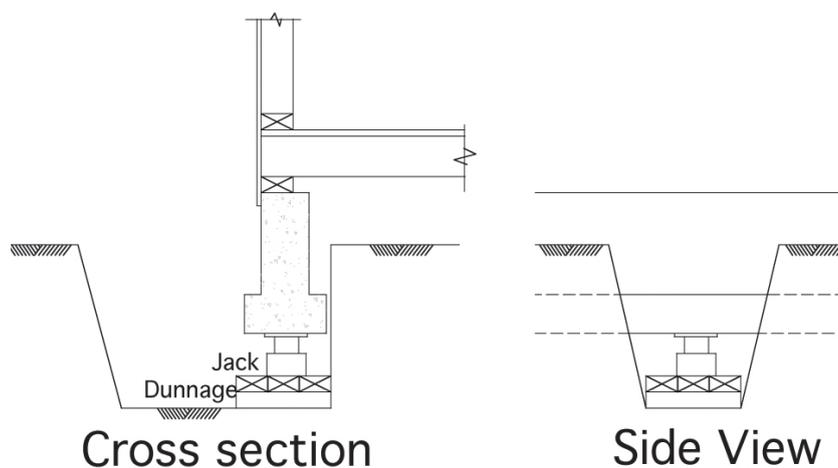
Figure A1.1: Lifting option 1 – Perimeter foundation jacking using portable jacks

Foundation releveling involves excavating pits at discrete locations to the perimeter of the foundation wall, and installing jacks in each pit to the underside of the wall to raise it to the correct level. With the foundation repositioned, flowable grout is introduced to the cavity created under the raised foundation. Once the grout is cured, the jacks are removed and the pits refilled.

For each of these four releveling processes, it is important that specialist contractors be used who are familiar with and adhere to the ASCE standard ASCE/G-I 53/10 "Compaction Grouting Consensus Guide". Practitioners must be able to demonstrate an appropriate track record with experienced personnel and purpose-built equipment, together with suitable levels of quality control and sufficient resources.

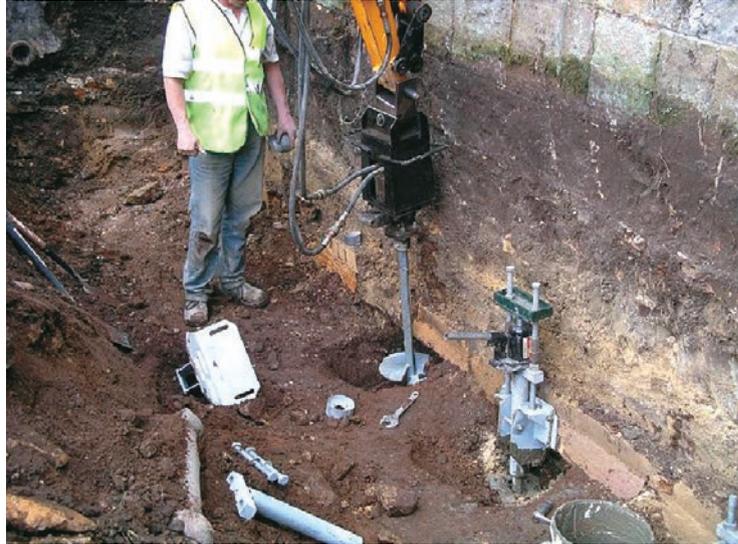
Figure A1.2: Lifting option 2 – Perimeter foundation jacking using piles (screw or similar)

Foundation releveling using screw piles involves installing piles at discrete locations to the perimeter of the foundation wall, along with under-wall shoes fitted with jacks or bolted jacking brackets to raise the foundation to the correct level. With the foundation repositioned, flowable grout is introduced to the cavity created under the raised foundation. Once the grout is cured, the jacks are removed. The screw piles may also be used as a permanent support.

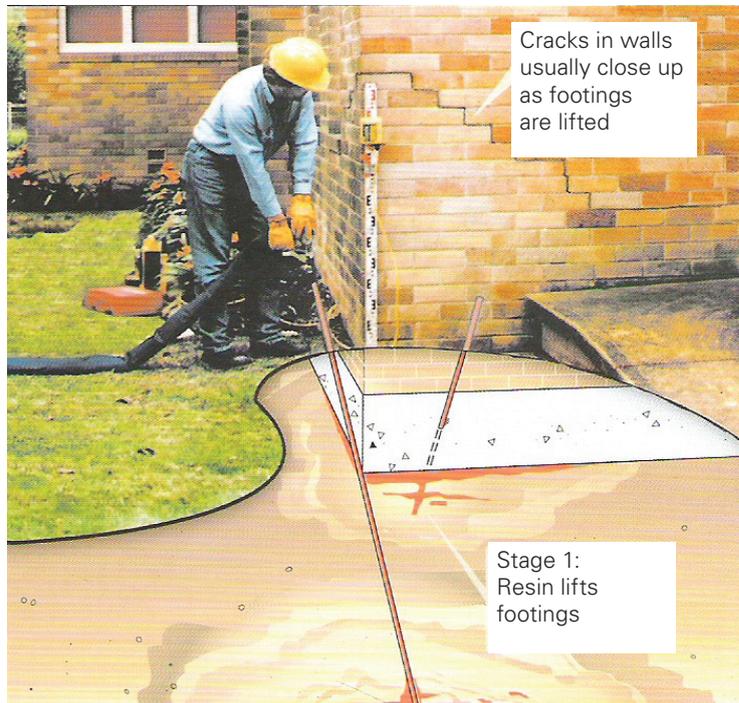
Figure A1.3: Lifting option 3 – Perimeter foundation jacking and slab releveling using engineered resin

This option is a proprietary lifting process where engineered resin is injected into the ground at multiple points along the foundation. The expanding resin lifts the foundation. This process also densifies the adjacent ground which serves as a reaction layer for the lifting operation. This should be carried out by specialist contractors using materials that meet the following minimum requirements:

- Inert and non-toxic
- Non-leaching
- Warranted durability for 50 years – no significant loss of density, corrosive strength, or shrinkage, demonstrated by proven in-ground history or accelerated testing.

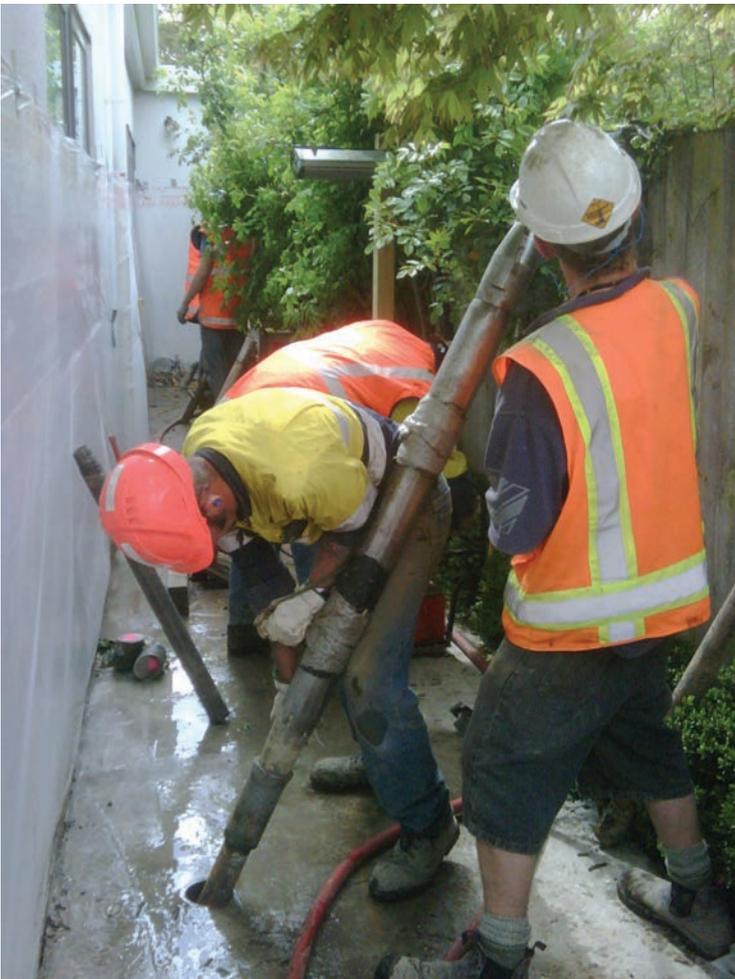
Figure A1.4: Lifting option 4 – Perimeter foundation jacking and slab releveling using thixotropic (low mobility) grout

This process involves drilling and inserting grout injection ports at predetermined locations and depths beneath the structure to permit the injection of grout. The thixotropic or low mobility grout (LMG) is introduced in a number of stages and at optimum pressures into the ground beneath the foundations (typically 1 m to 3 m below the foundations) to raise the ground immediately below the structure together with the structure back to its original level. This process has been shown to improve the ground bearing capacity.

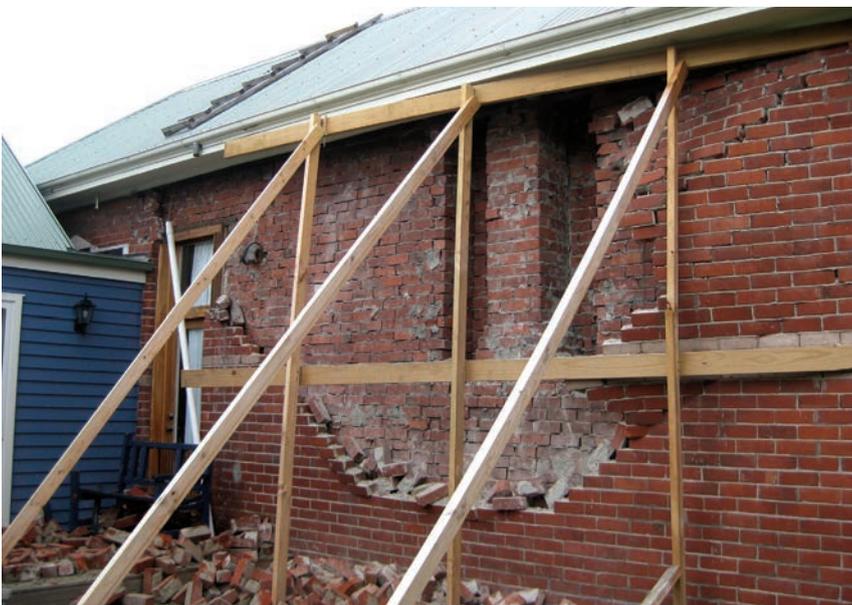
Figure A3.1. Failed double skin unreinforced masonry wall showing chimney cast integrally with the wall

Note: The chimney is no longer in service and the roof has been re-clad.

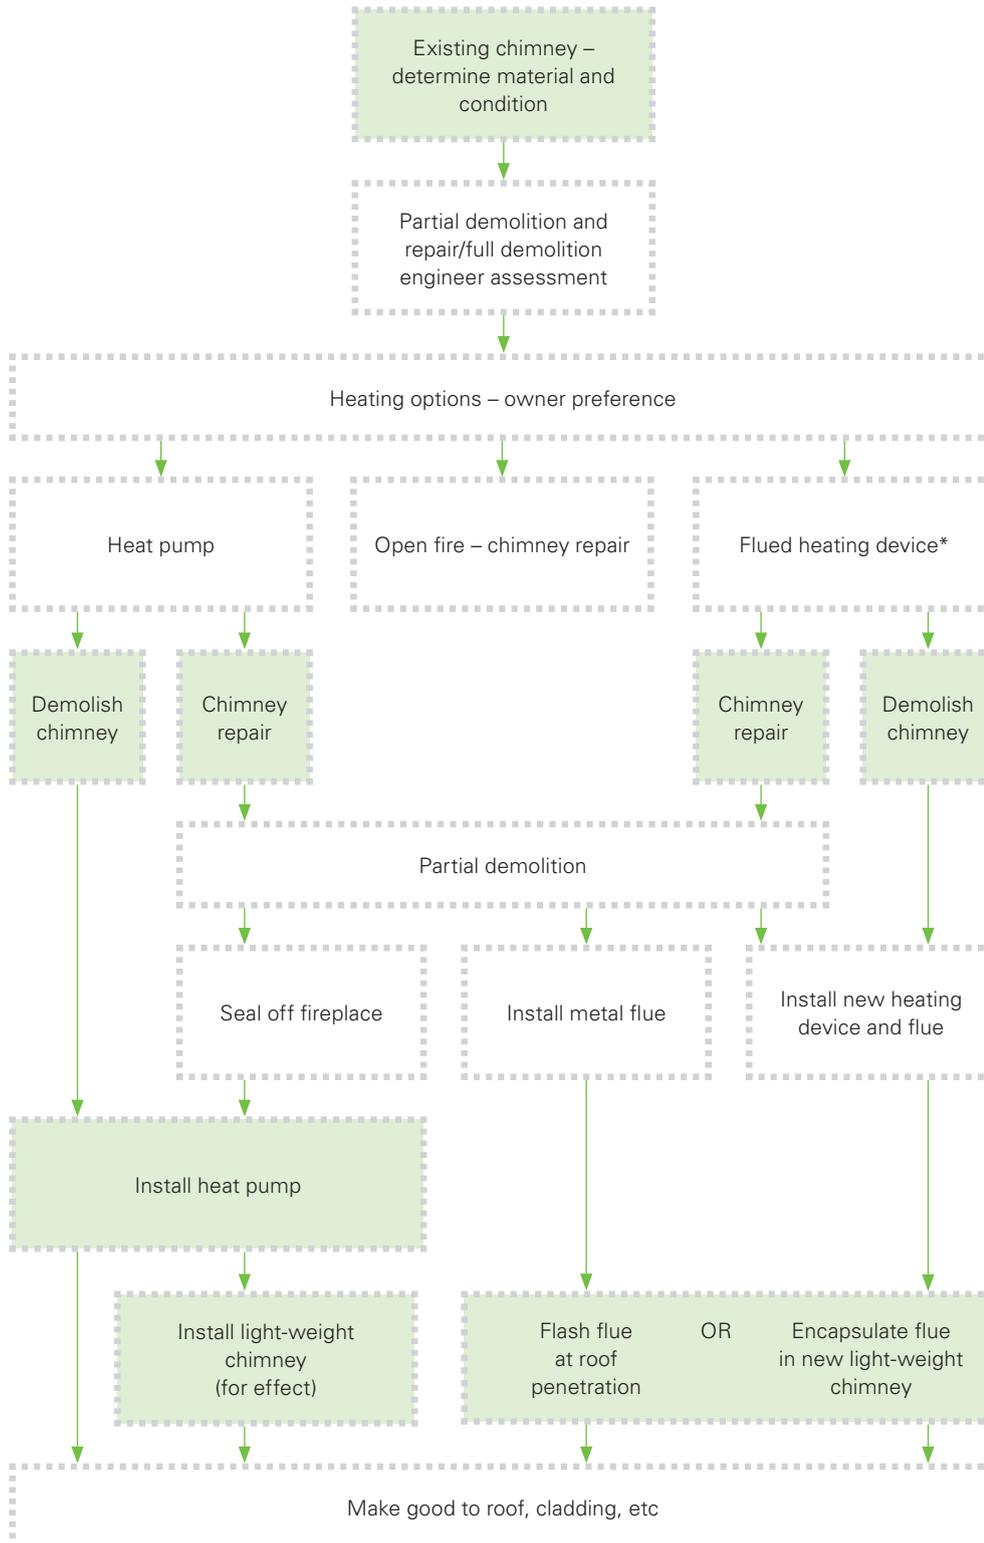
Figure A3.2: Process for assessment and decision on repair or replacement of chimneys

Note: Approved heating unit – log burner/pellet fire/gas fire.

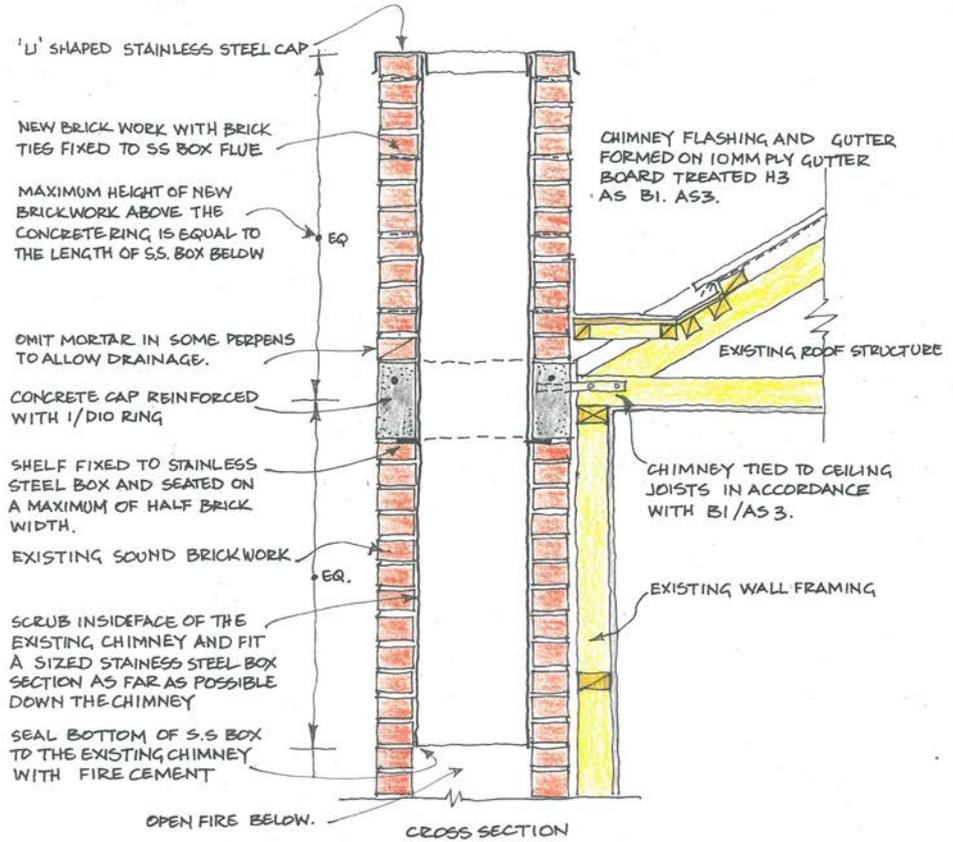
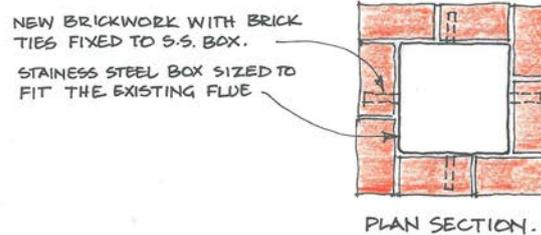
SUGGESTED CHIMNEY RECONSTRUCTION
REPLACEMENT BRICK CHIMNEY WITH AN OPEN FIRE.
ONLY WHERE THE CHIMNEY STRUCTURE BELOW ROOF
LEVEL IS CONFIRMED SOUND BY AN ENGINEER.

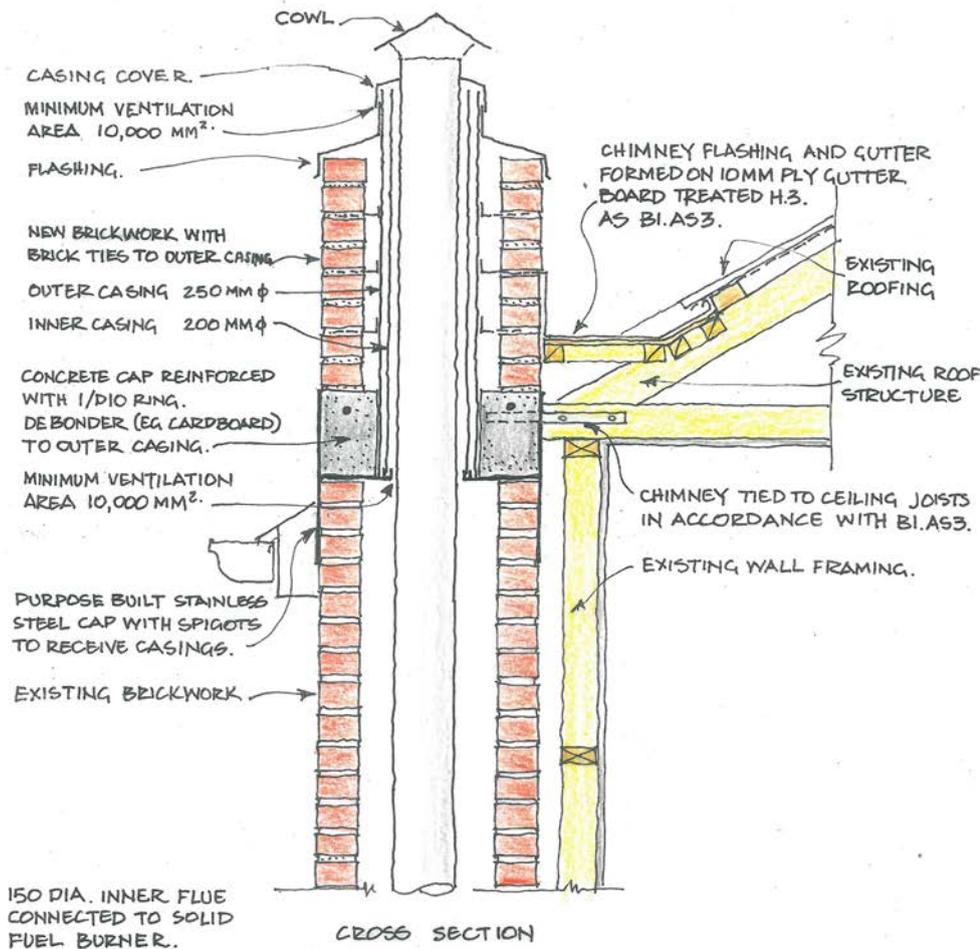
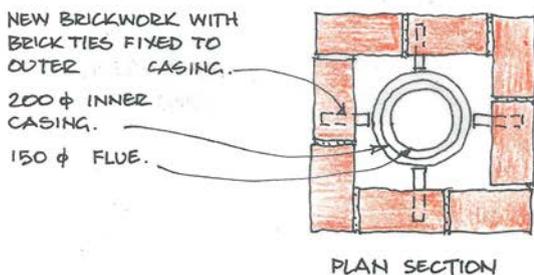
Figure A3.4: Chimney Option 2

SUGGESTED CHIMNEY RECONSTRUCTION
 REPLACEMENT BRICK CHIMNEY WITH A SOLID FUEL BURNER
 ONLY WHERE THE CHIMNEY STRUCTURE BELOW ROOF LEVEL
 IS CONFIRMED SOUND BY AN ENGINEER.

NOTE: SHORTEN HEIGHT OF BRICKWORK ABOVE THE CONCRETE RING, AND EXTEND THE FLUE AND CASINGS TO THE REQUIRED HEIGHT ABOVE THE ROOF IF AT ALL POSSIBLE.

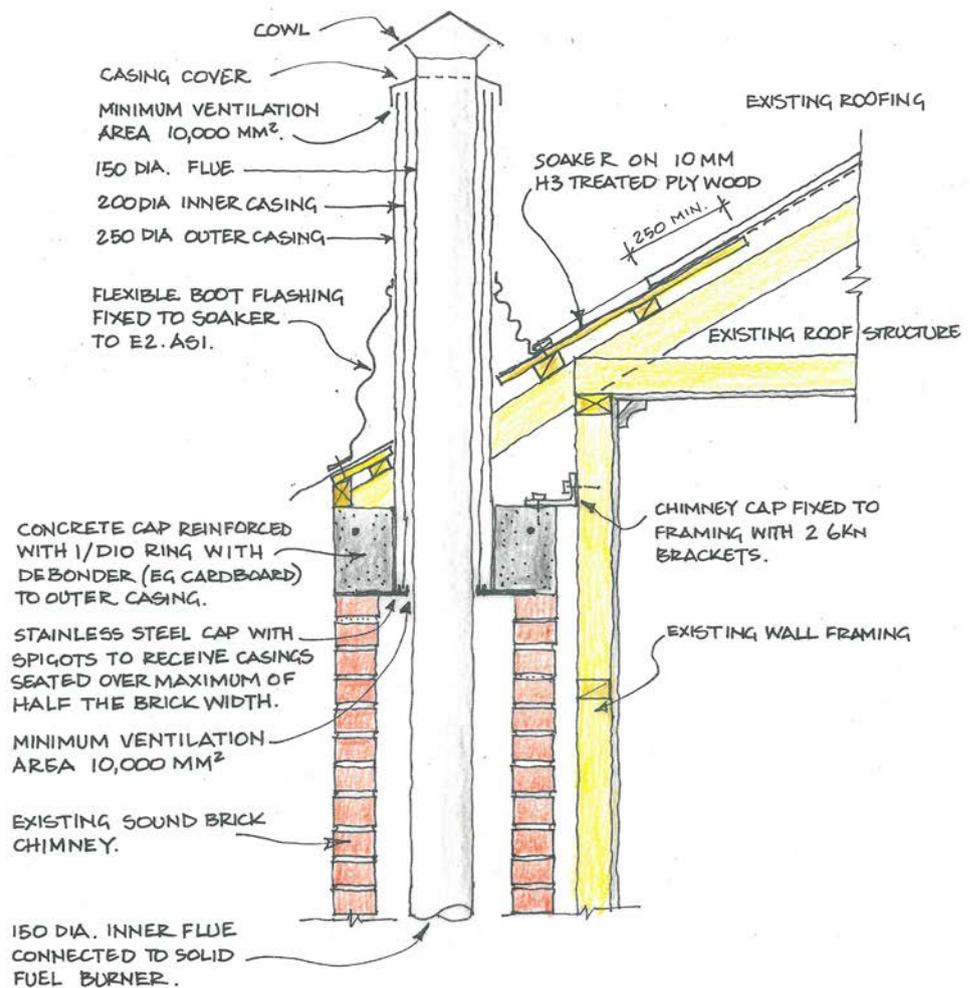
REPLACEMENT LIGHTWEIGHT FLUE WITH A SOLID FUEL BURNER
 ONLY WHERE THE CHIMNEY STRUCTURE BELOW ROOF LEVEL
 IS CONFIRMED SOUND BY AN ENGINEER.

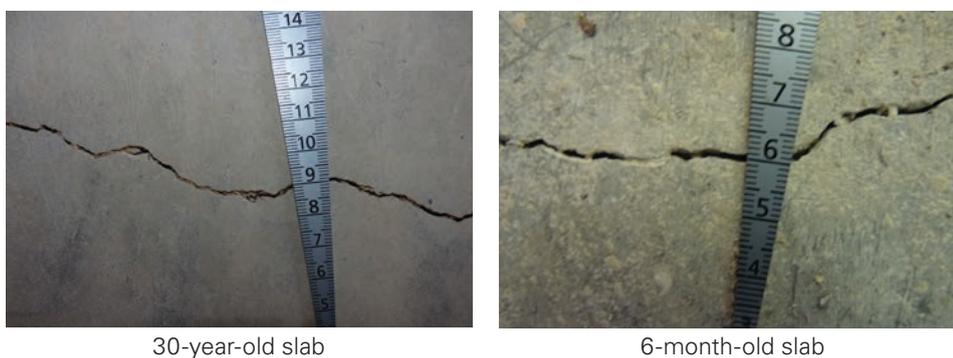
Figure A4.2: Typical shrinkage cracking in concrete slabs

Random cracks in the floor slab which reduce in width to close to indiscernible as they approach the perimeter foundation (or any internal foundation) are shrinkage cracks and are not caused by an earthquake.

As shrinkage cracks occur frequently in concrete floor slabs, it is considered that small cracks (up to 1 mm, see Figure A4.2), whether caused by an earthquake or by shrinkage, can be left unrepaired, unless the shrinkage has had a visible effect on the floor covering.
